# **Drainage Maintenance Activity Letter Report**

**Rockwool Industries, Inc.  
Federal Superfund Site  
1741 Taylors Valley Road  
Belton, Bell County, Texas**

**Texas Commission on  
Environmental Quality**

**September 4, 2012**

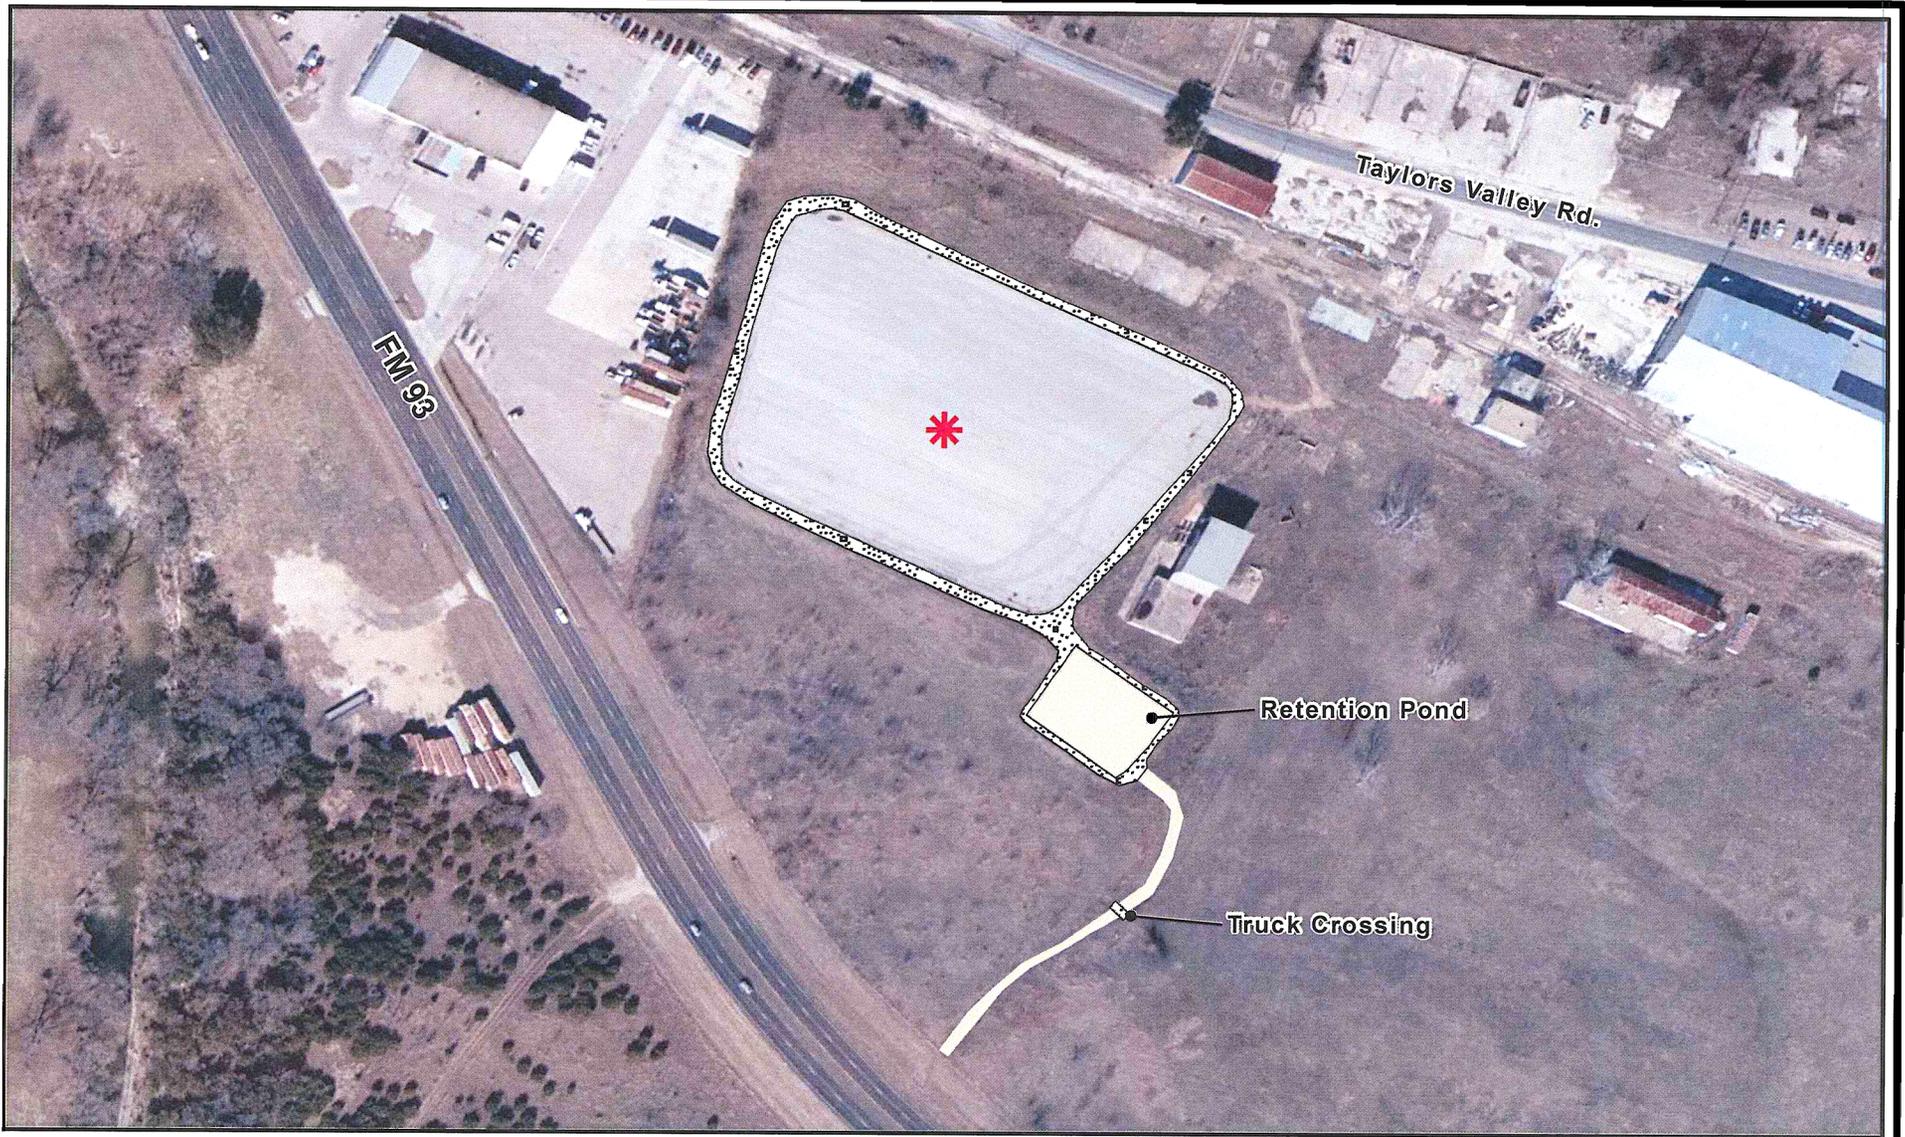
Drainage maintenance activities as specified in TCEQ Work Order No. 248-0058 have been properly completed. Approximately 54,000 sq. ft. of land was cleared/cleaned out and approximately 32,000 sq. ft. of land had rip-rap installed after clearing. Figure 1 depicts the cleared and rip-rap areas.

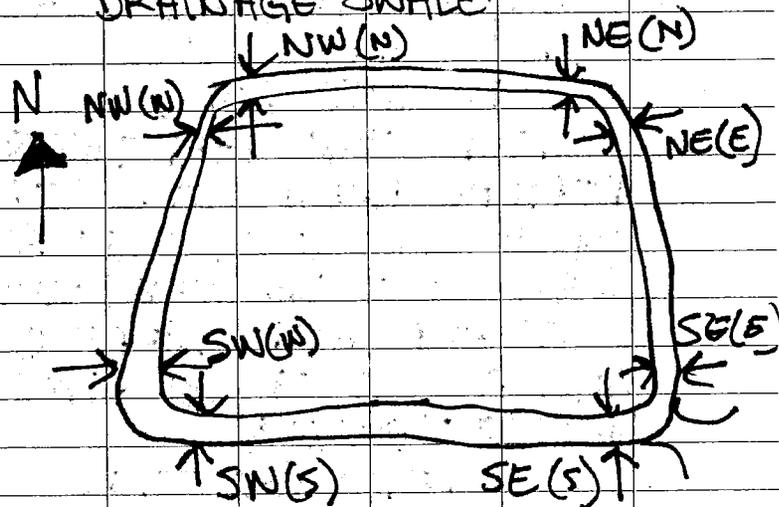
(70) ROCKWOOL 8.17.12 SE —  
0830 TAKING MEASUREMENTS OF  
DRAWAGE SWALE

EACH MEASUREMENT TAKEN  
ACROSS THE TOP OF THE  
BERM

AND AN APPROXIMATE DEPTH,  
WITHOUT THE RIP-RAP.

NW(N)	9'6"	1' -
NW(W)	9' -	1'6"
NE(N)	12' -	1'8"
NE(E)	12'6"	2' -
SW(S)	14'6"	3'6"
SW(W)	14' -	2'6"
SE(S)	22' -	4' -
<del>SE(W)</del>		
SE(E)	20'6"	3'6"

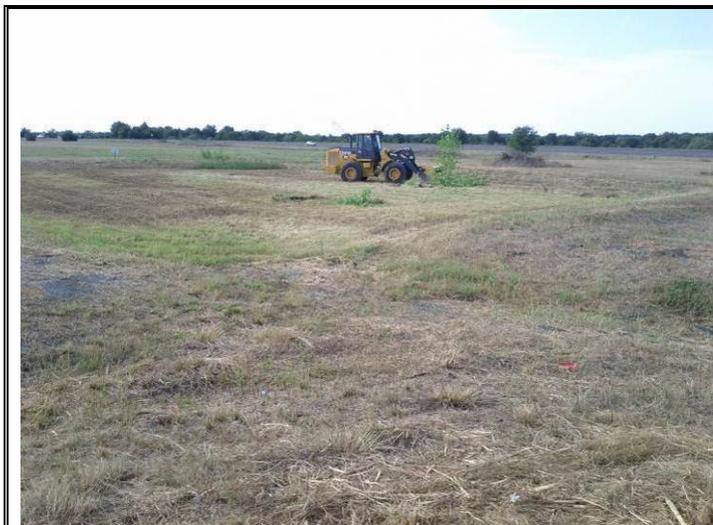
Date: August 13, 2012  
Photo Taken By: Sara Eatman  
Description: The retention pond being cleared of 3 small trees and vegetation (looking SE).

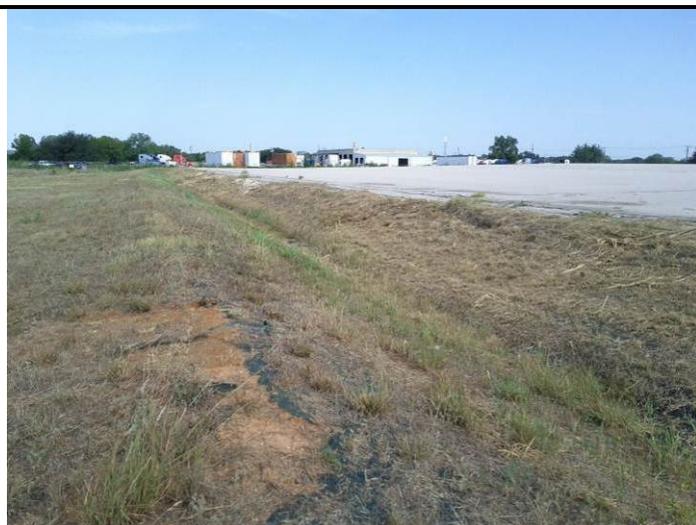
Date: August 13, 2012  
Photo Taken By: Sara Eatman  
Description: Swale along the southern edge of the landfill cap (looking W).

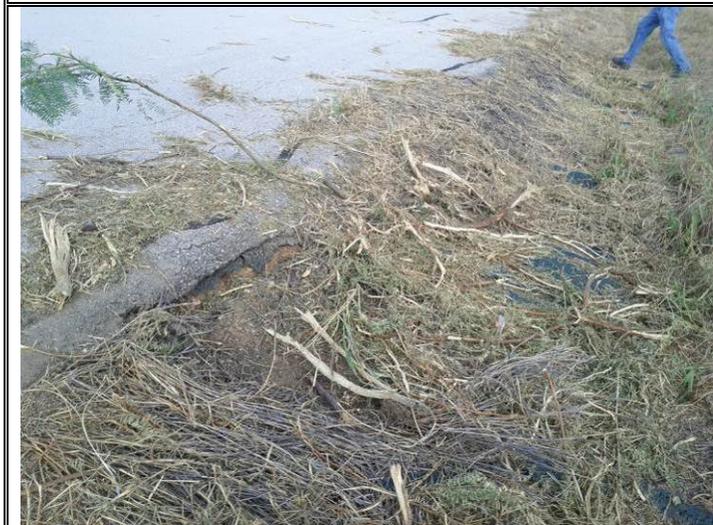
Date: August 13, 2012  
Photo Taken By: Sara Eatman  
Description: The edge of the landfill cap, typical.

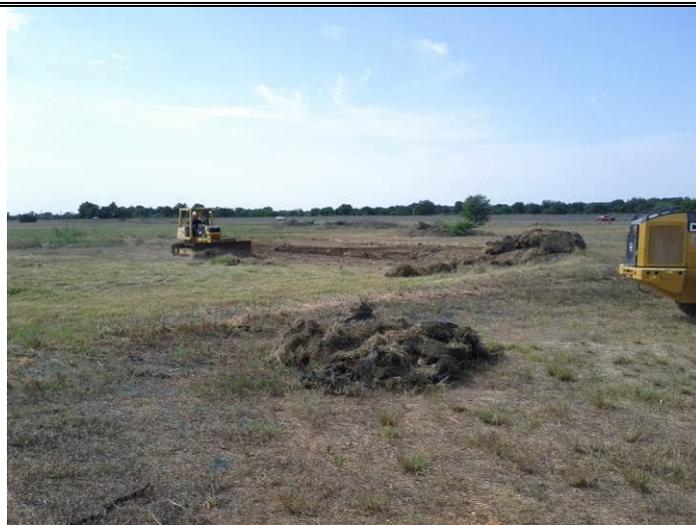
Date: August 13, 2012  
Photo Taken By: Sara Eatman  
Description: Initial scraping of the retention pond, and the first accumulations of the plastic landscaping netting (looking SE).

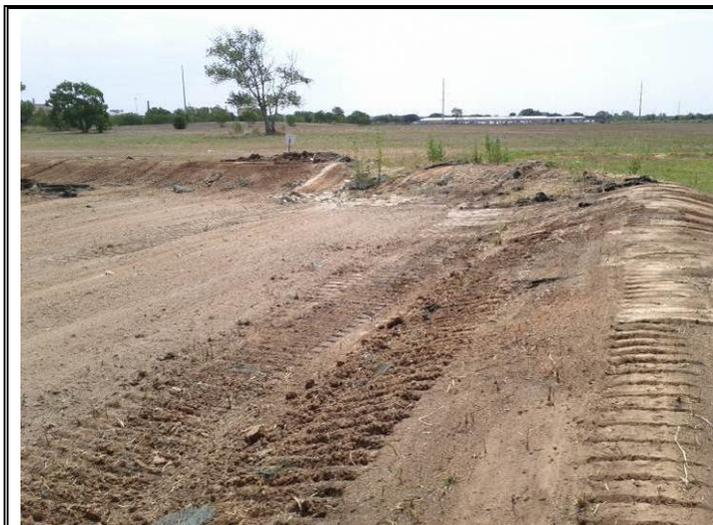
Date: August 13, 2012  
Photo Taken By: Sara Eatman  
Description: Cleared pond, including the outlet culvert (looking E).

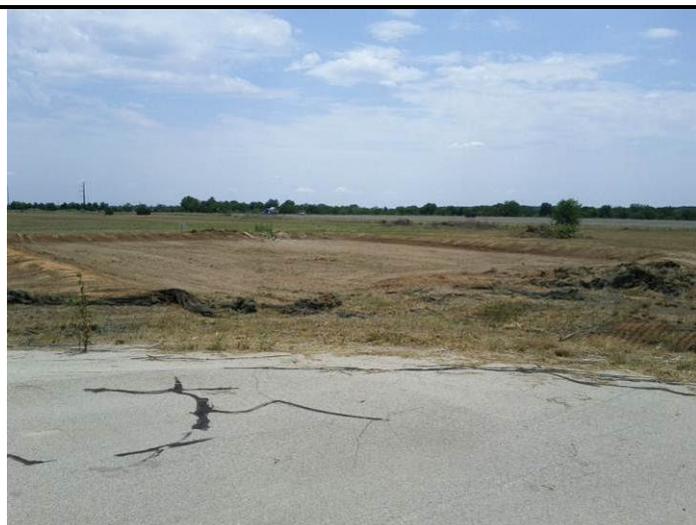
Date: August 13, 2012  
Photo Taken By: Sara Eatman  
Description: The retention pond (looking SE).

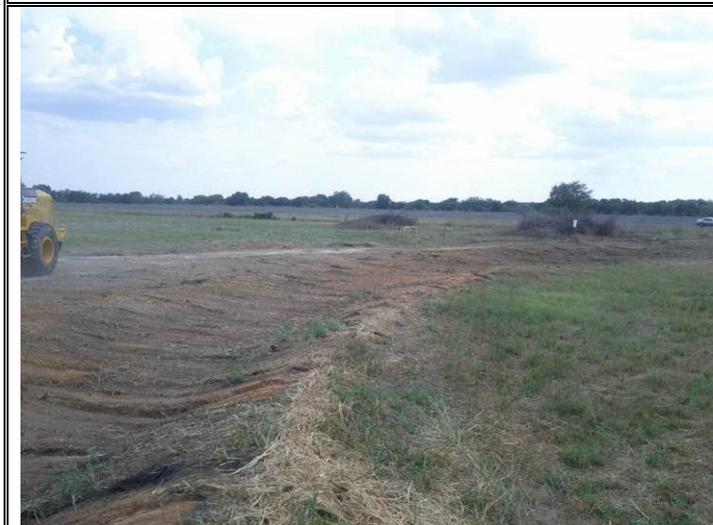
Date: August 13, 2012  
Photo Taken By: Sara Eatman  
Description: Drainage swale (looking SE).

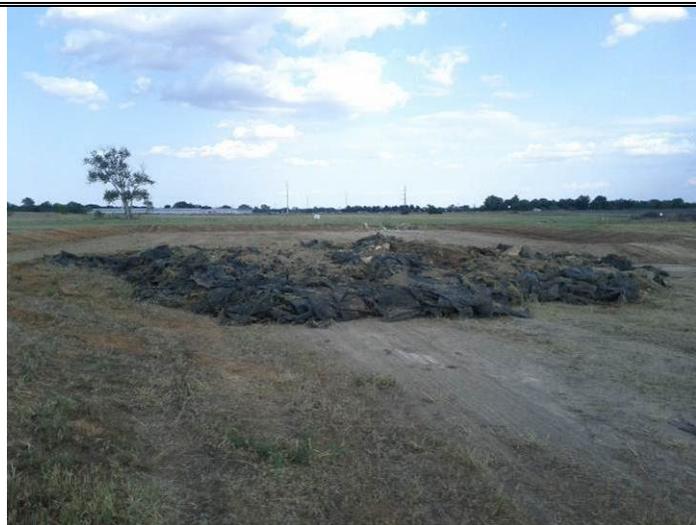
Date: August 13, 2012  
Photo Taken By: Sara Eatman  
Description: Excess soil, vegetation, and landscape netting, piled between the retention pond and the southeastern corner of the landfill (looking E).

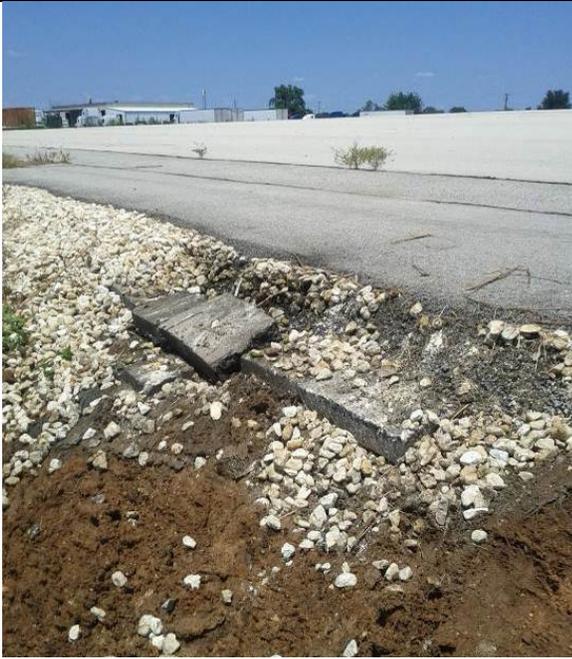
(3) THE AREA OF THE CAP  
WHERE THERE ARE BLOCKS  
OF ASPHALT AND ROCK MUST BE  
MAINTAINED AS IT IS → IT WAS  
AN EPA FIX FOR A PART  
OF THE CAP THAT HAD  
BEGUN TO COLLAPSE

Date: August 14, 2012  
Photo Taken By: Sara Eatman  
Description: Southern edge of the MATCON cap, previously installed reinforcements (looking NW).

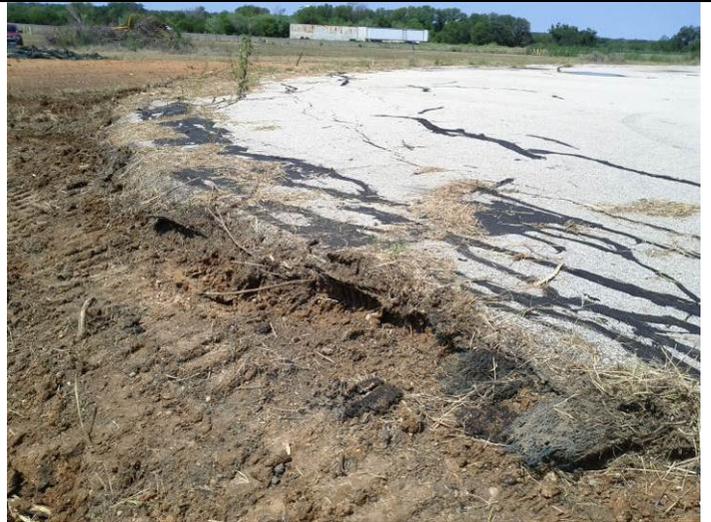
Date: August 14, 2012  
Photo Taken By: Sara Eatman  
Description: MATCON cap edge, typical.

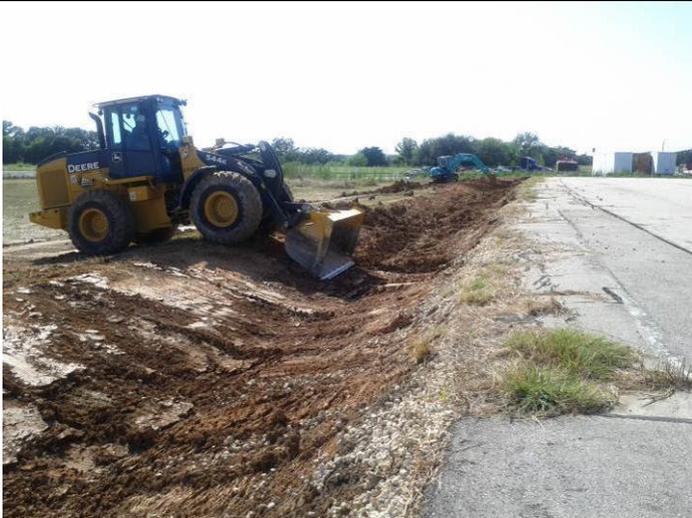
Date: August 14, 2012  
Photo Taken By: Sara Eatman  
Description: Scraping vegetation from the swale on the north side of the MATCON cap (looking E).

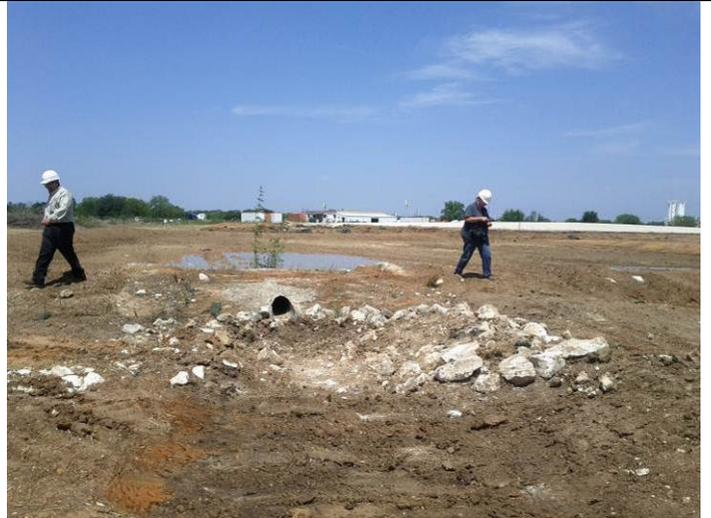
Date: August 15, 2012  
Photo Taken By: Sara Eatman  
Description: Retention pond outlet before further contouring and installation of rip-rap (looking W).

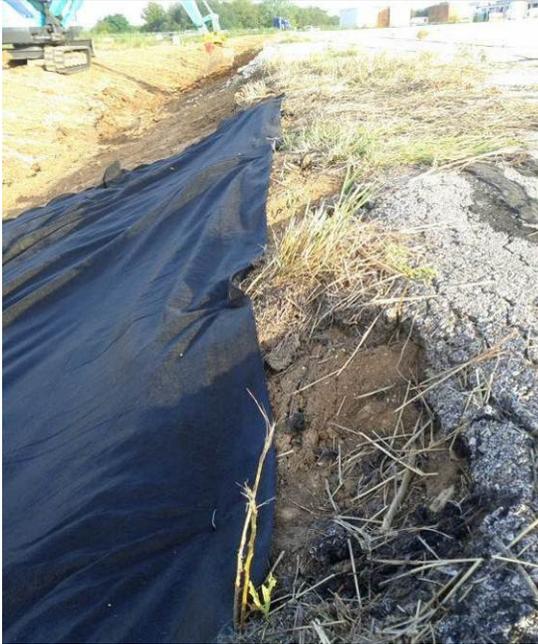
Date: August 16, 2012  
Photo Taken By: Sara Eatman  
Description: Installation of filter fabric on south edge of the cap, using landscaping staples (looking W).

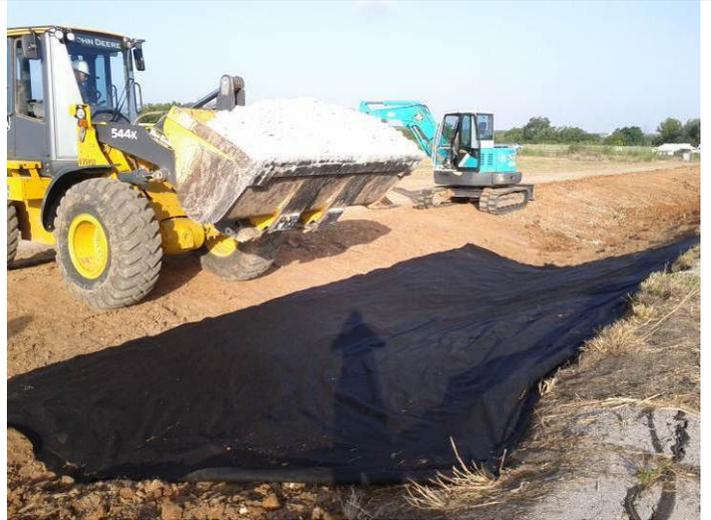
Date: August 16, 2012  
Photo Taken By: Sara Eatman  
Description: First load of rip-rap on the filter fabric (looking SW).

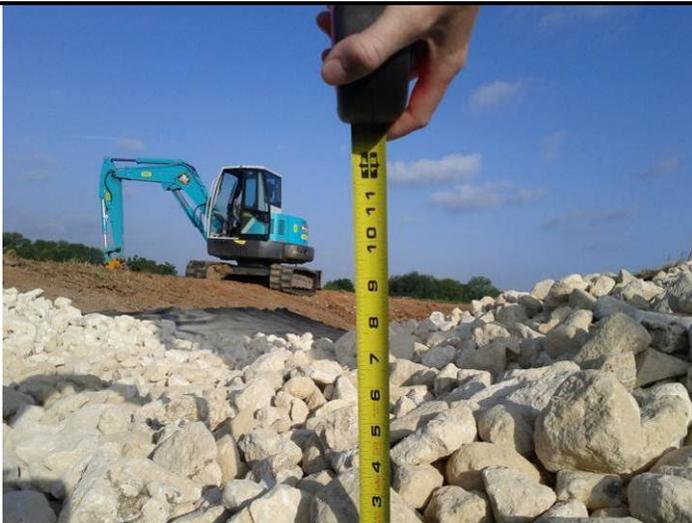
Date: August 16, 2012  
Photo Taken By: Sara Eatman  
Description: Installed thickness of rip-rap, typical.

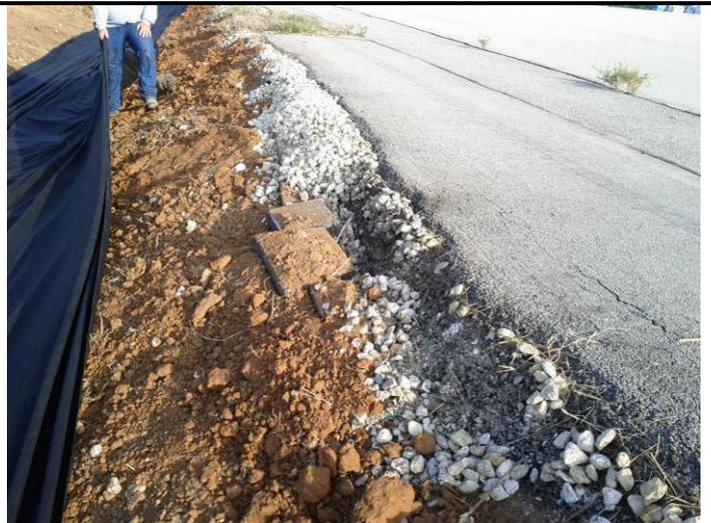
Date: August 16, 2012  
Photo Taken By: Sara Eatman  
Description: Rip-rap installation over reinforced area (looking W).

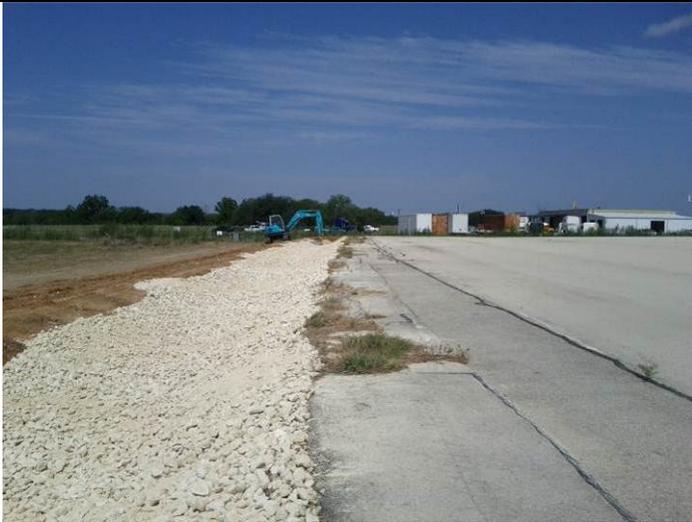
Date: August 16, 2012  
Photo Taken By: Sara Eatman  
Description: Rip-rap on the drainage swale on the south edge of the landfill cap (looking W).

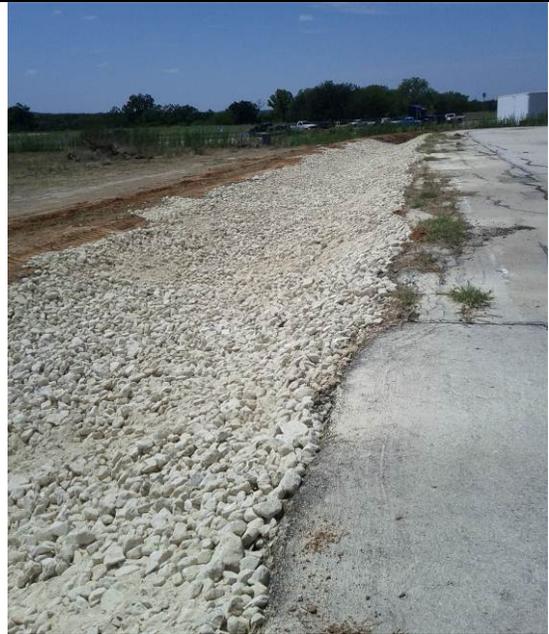
Date: August 16, 2012  
Photo Taken By: Sara Eatman  
Description: Rip-rap on the drainage swale on the north edge of the landfill cap (looking E).

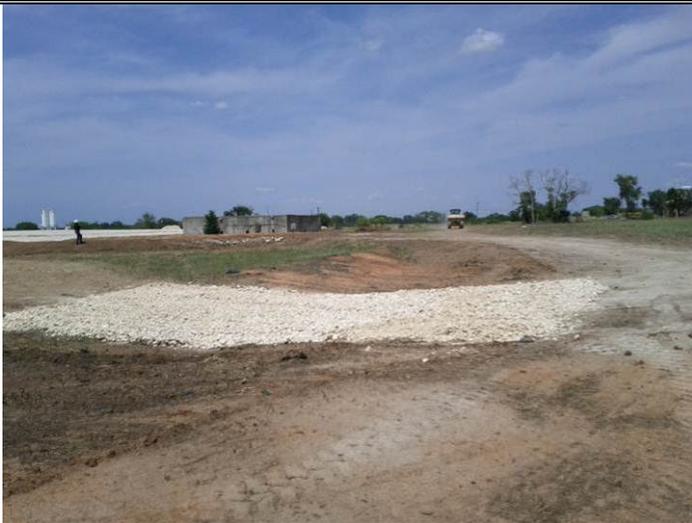
Date: August 17, 2012  
Photo Taken By: Sara Eatman  
Description: Rip-rap truck crossing for the swale between the retention pond and the FM 93 culverts (looking S).

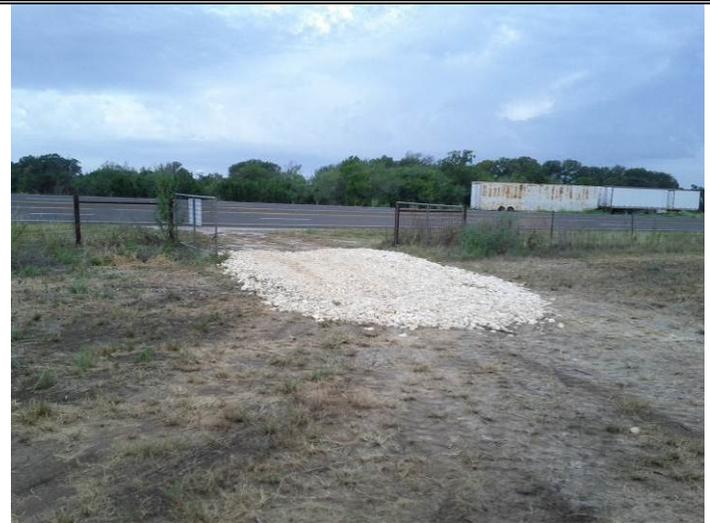
Date: August 18, 2012  
Photo Taken By: Sara Eatman  
Description: Rip-rap at the southern entrance to the property (looking S).

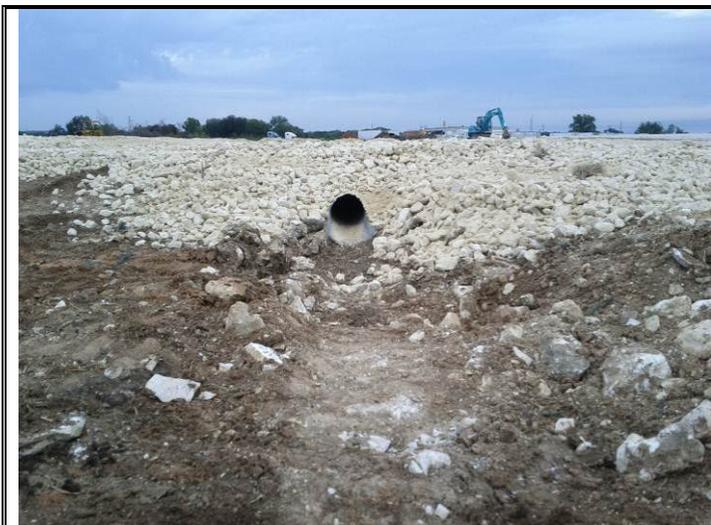
Date: August 18, 2012  
Photo Taken By: Sara Eatman  
Description: Rip-rap on the southeast berm of the retention pond, around the culvert (looking NW).

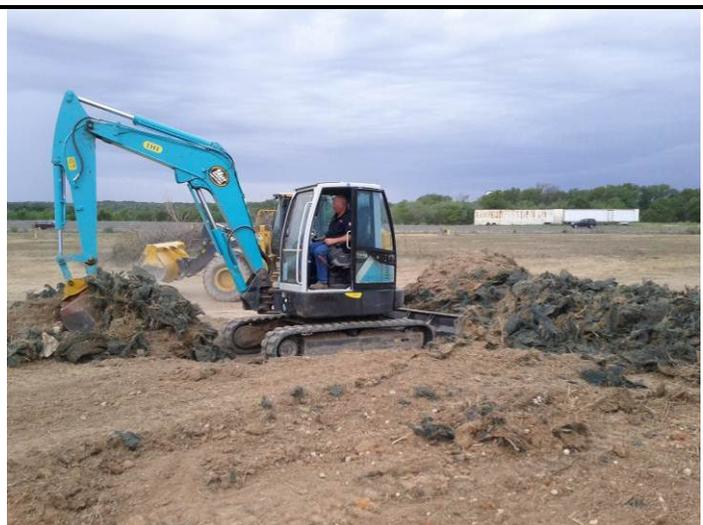
Date: August 18, 2012  
Photo Taken By: Sara Eatman  
Description: Removal of plastic landscaping netting from the excess soil stockpile (looking SE).

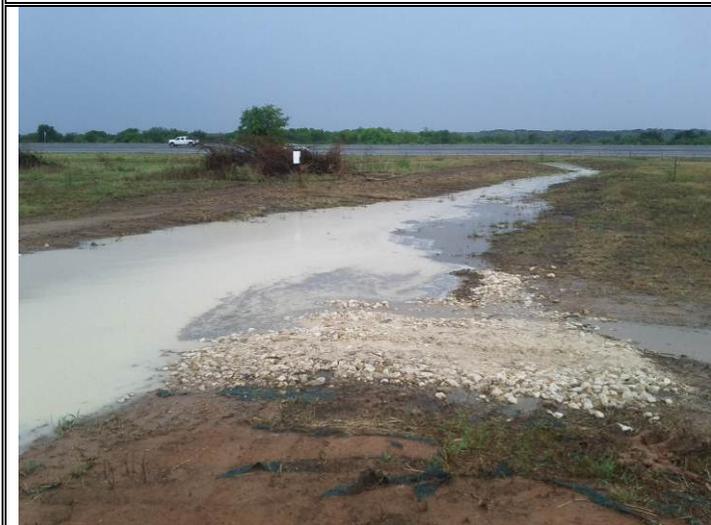
Date: August 18, 2012  
Photo Taken By: Sara Eatman  
Description: Stormwater flowing down the drainage swale toward FM 93 culvert (looking S).

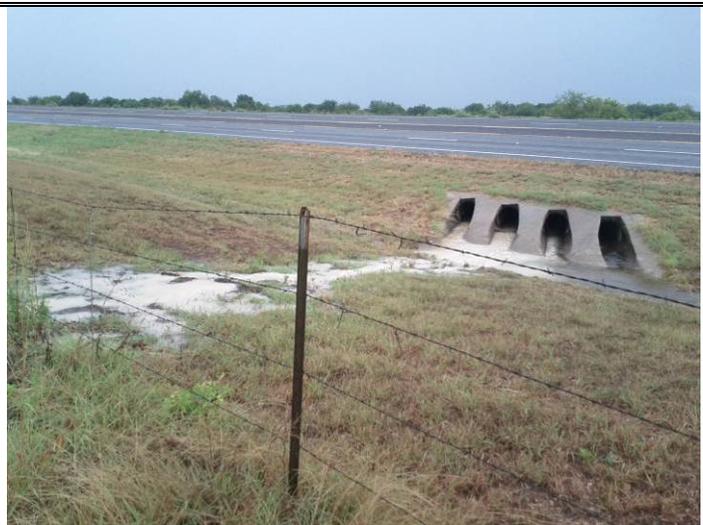
Date: August 18, 2012  
Photo Taken By: Sara Eatman  
Description: Stormwater flowing from the edge of the property toward the FM 93 culverts (looking SE).

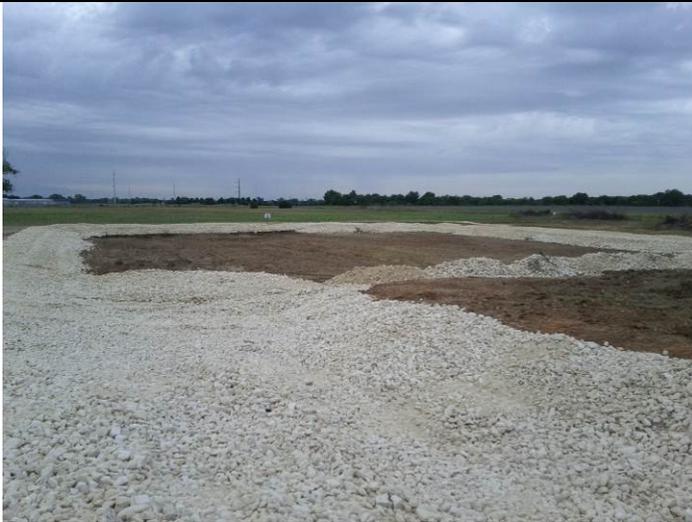
Date: August 18, 2012  
Photo Taken By: Sara Eatman  
Description: Rip-rap around the retention pond berms and at the MATCON cap swale outlet (looking SE).

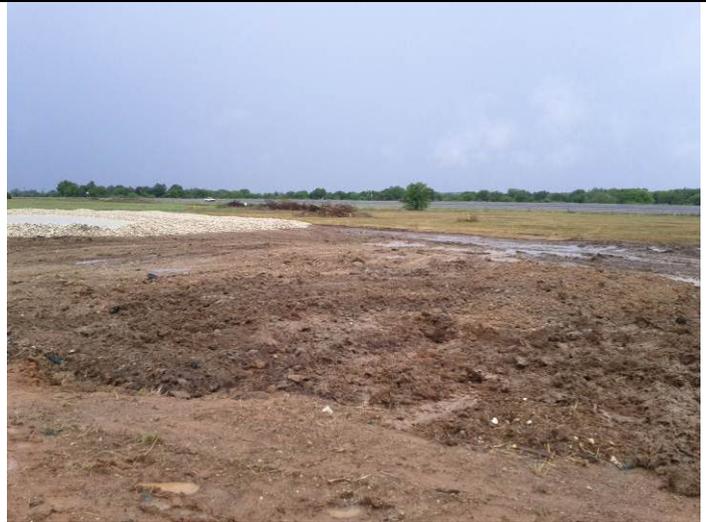
Date: August 18, 2012  
Photo Taken By: Sara Eatman  
Description: Excess soil stockpile, compacted with plastic netting removed (looking SE).

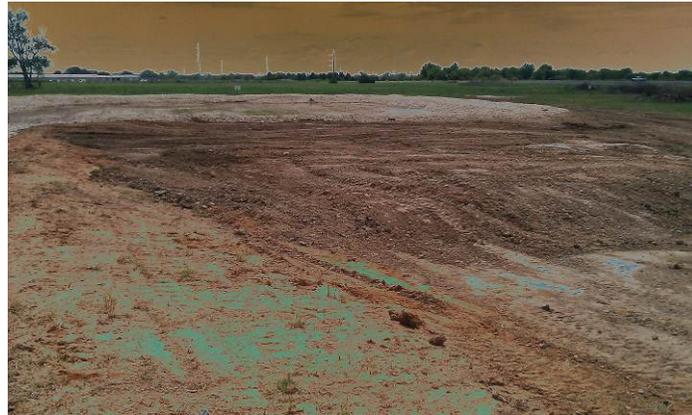
Date: August 27, 2012  
Photo Taken By: Billy Gamblin  
Description: Contoured excess soil stockpile (looking E).
