Field Summary Report Letter Report

**Rockwool Industries, Inc.
Federal Superfund Site
1741 Taylors Valley Road
Belton, Bell County, Texas**

July 11, 2013

Re: Rockwool Industries, Inc. / Belton, Site # SUP033, Field Summary Report

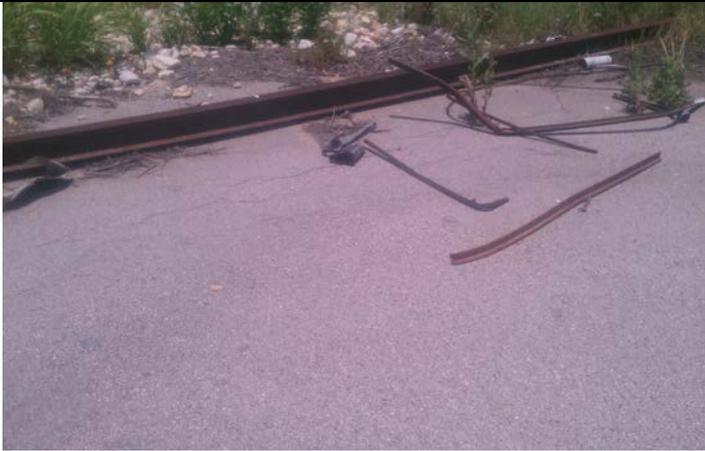
The MATCON cover itself contains some debris (railroad rail, fence posts, and logs) near the western edge that was not observed in previous inspections. Cracks evident in the MATCON cover seem to be of similar density and size as what was observed in the August 2012 inspection. A metal ruler was utilized to gauge the depths of the cracks. Depths measured in the cracks ranged from two to five inches with most being three to four inches in depth; however, due to the jagged nature of the cracks, the ruler usually did not penetrate the cracks completely. In the bottom of the cracks a sandy material was usually encountered.

Date: June 12, 2013 Direction: NNW
Photo Taken By: William Gamblin
Description: Rail and other metal debris in northwest corner of MATCON

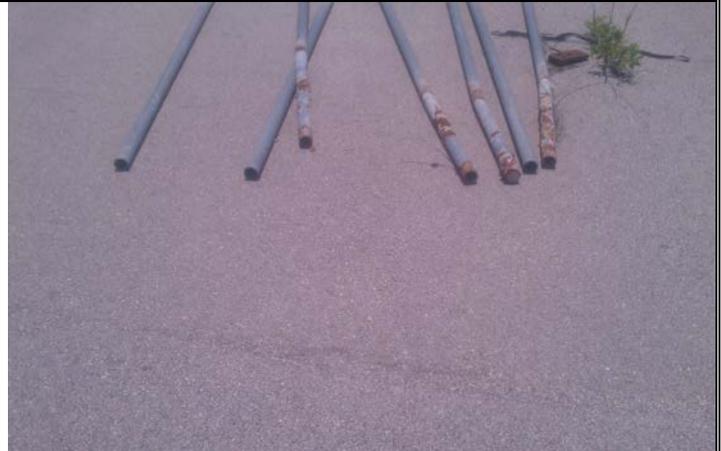
Date: June 12, 2013 Direction: S
Photo Taken By: William Gamblin
Description: Fence post pipe along west side of MATCON

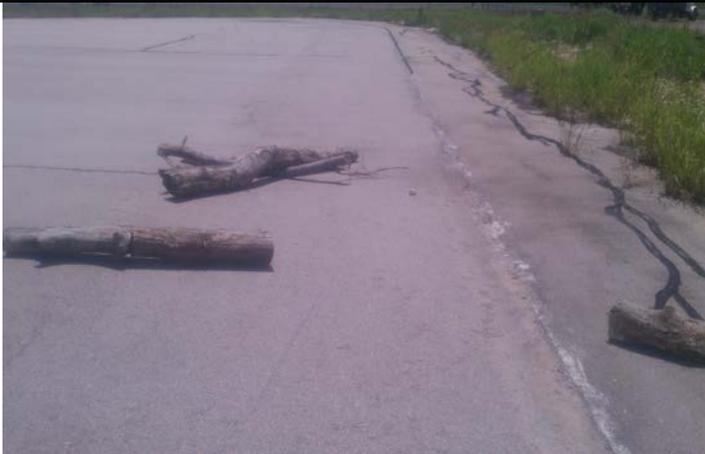
Date: June 12, 2013 Direction: S
Photo Taken By: William Gamblin
Description: Logs along west side of MATCON

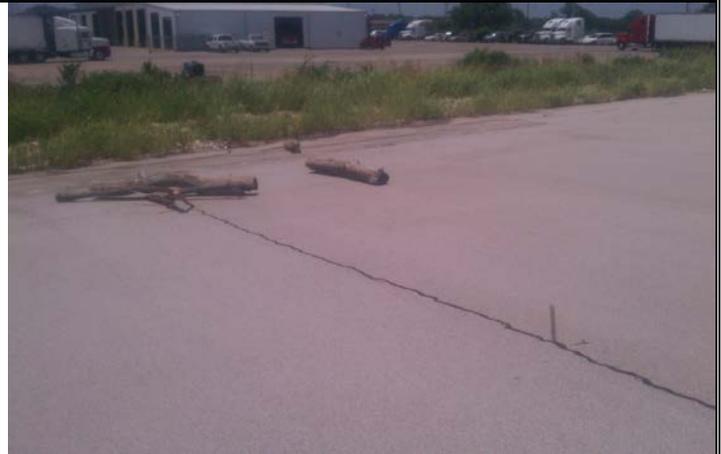
Date: June 12, 2013 Direction: NW
Photo Taken By: William Gamblin
Description: Crack in MATCON. Note metal ruler in crack.

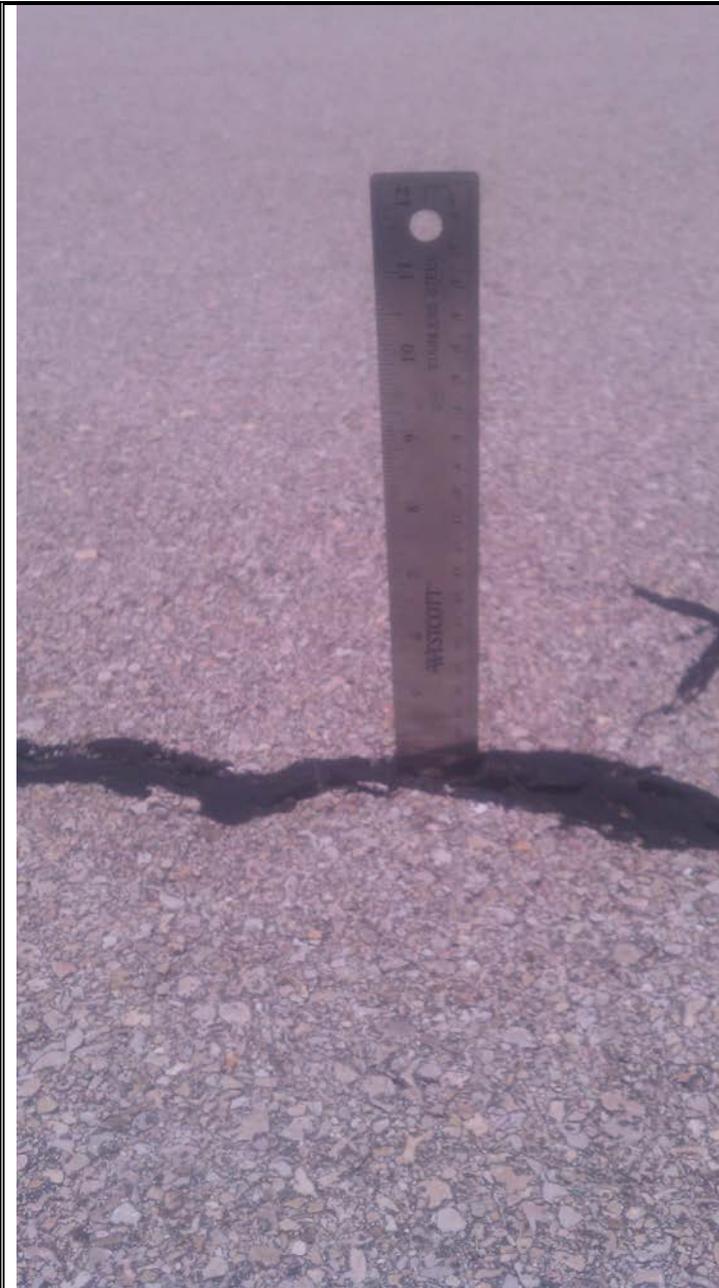
Date: June 12, 2013 Direction: NW
Photo Taken By: William Gamblin
Description: Ruler in Crack in MATCON. Ruler penetrated ~3.5 inches.

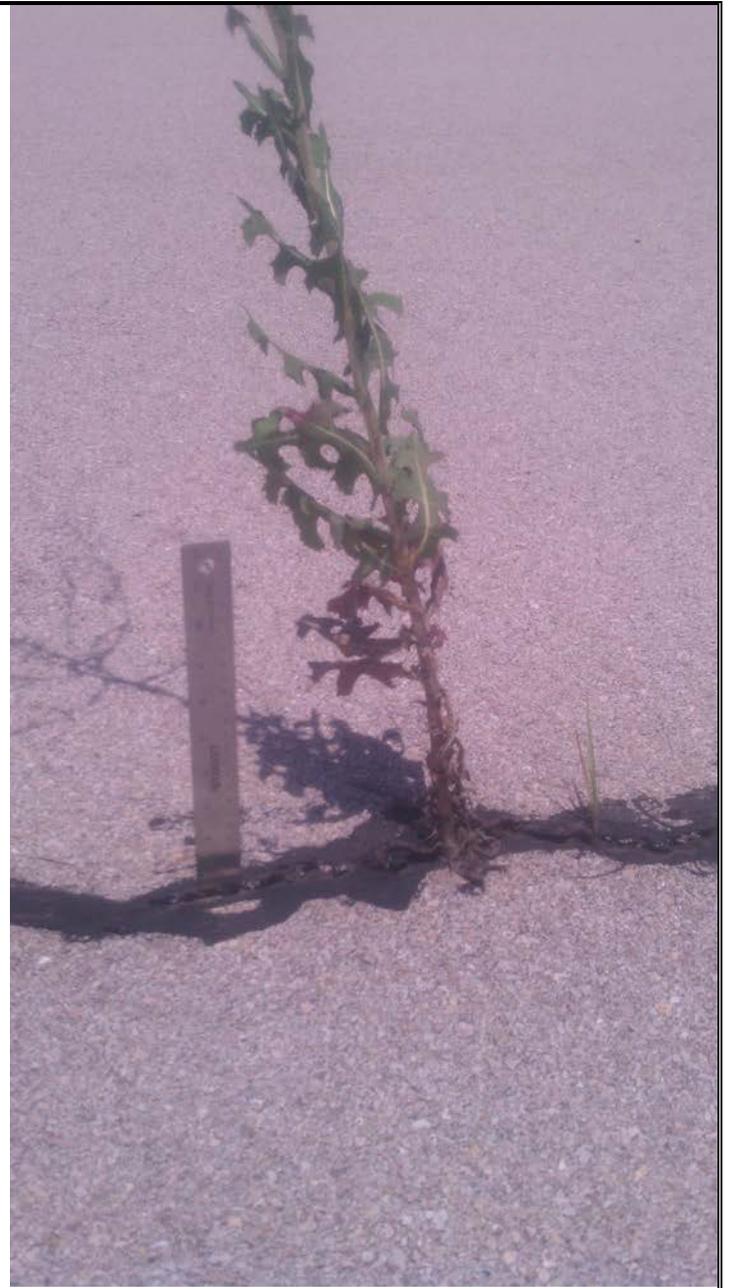
Date: June 12, 2013 Direction: NW
Photo Taken By: William Gamblin
Description: Ruler in Crack in MATCON.

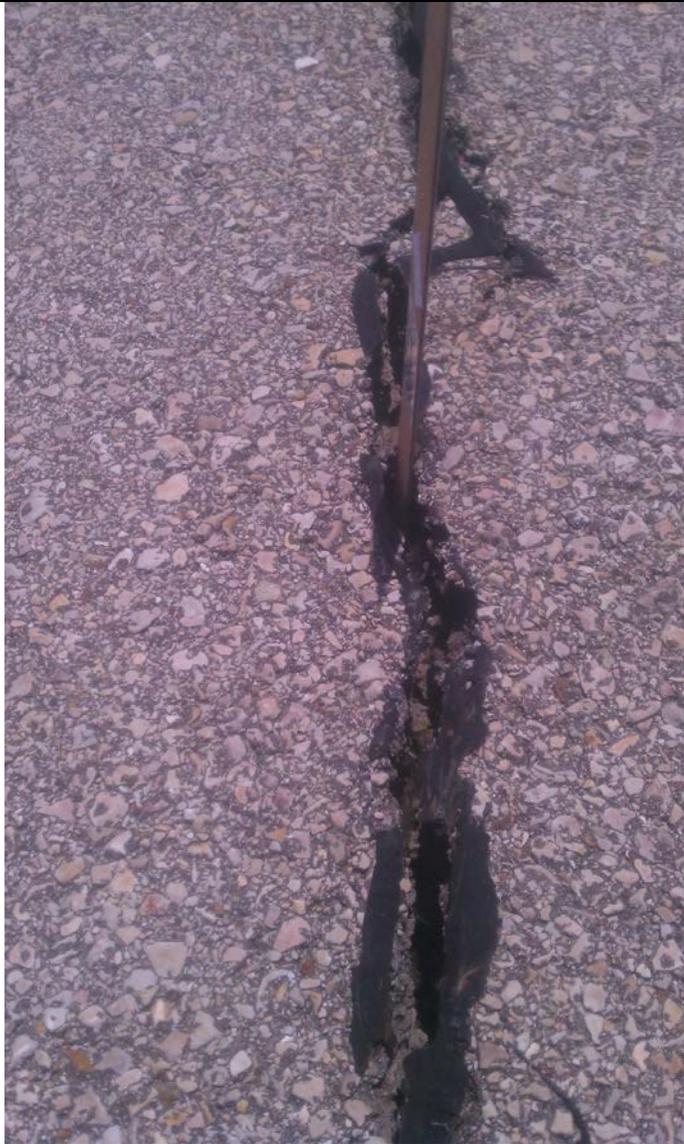
Date: June 12, 2013 Direction: S
Photo Taken By: William Gamblin
Description: Ruler in Crack in MATCON. Ruler
penetrated ~4 inches.

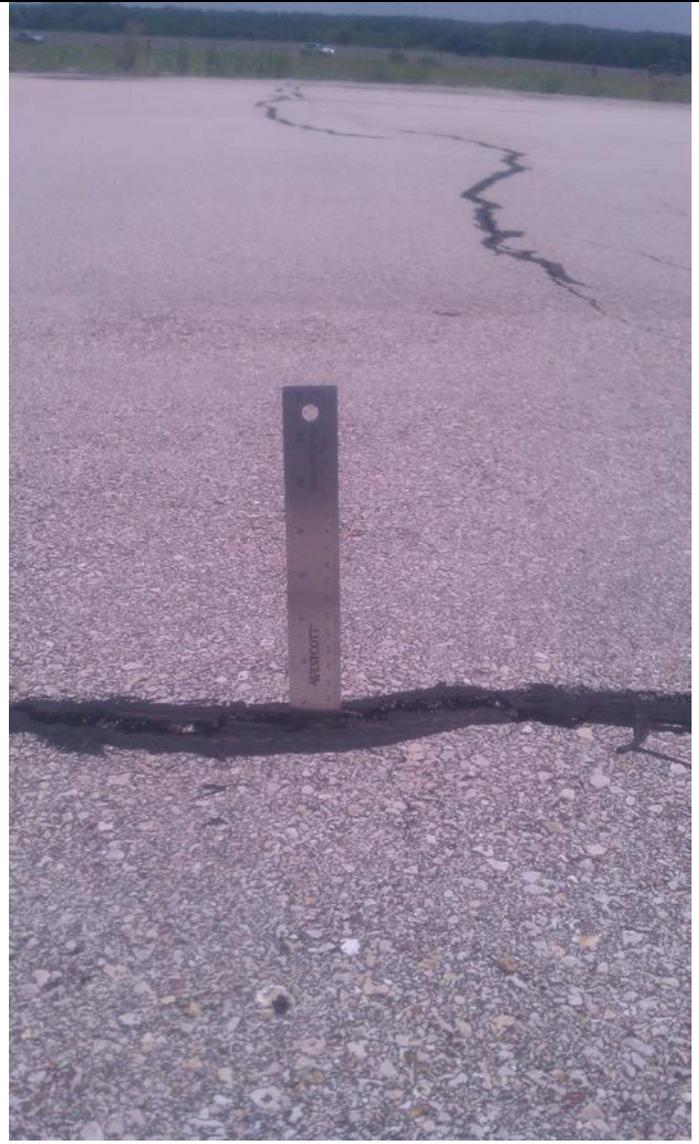
Date: June 12, 2013 Direction: S
Photo Taken By: William Gamblin
Description: Ruler in Crack in MATCON. Ruler
penetrated ~5 inches.

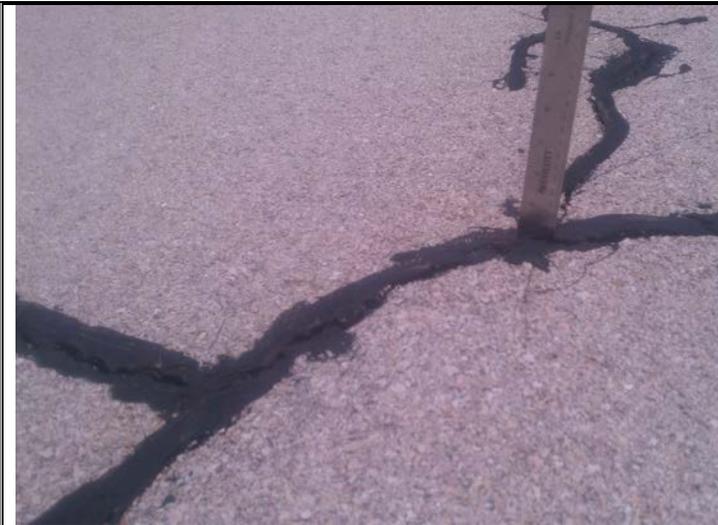
Date: June 12, 2013 Direction: NE
Photo Taken By: William Gamblin
Description: Ruler in crack in MATCON

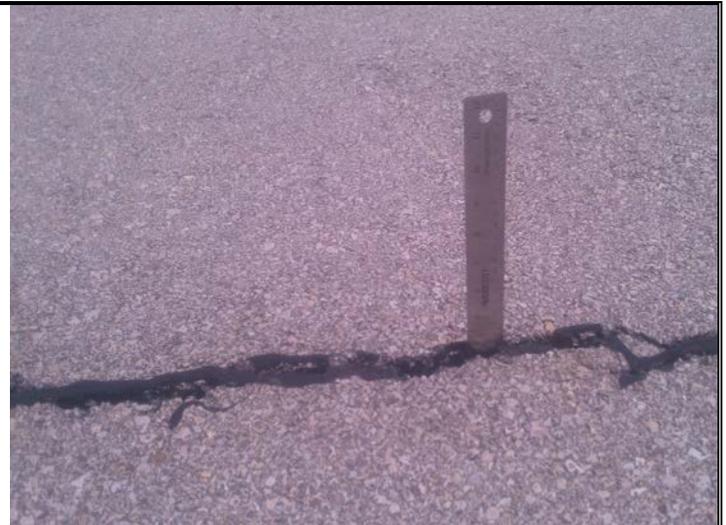
Date: June 12, 2013 Direction: NNE
Photo Taken By: William Gamblin
Description: Ruler in crack near center of MATCON. Ruler penetrated ~4 inches.

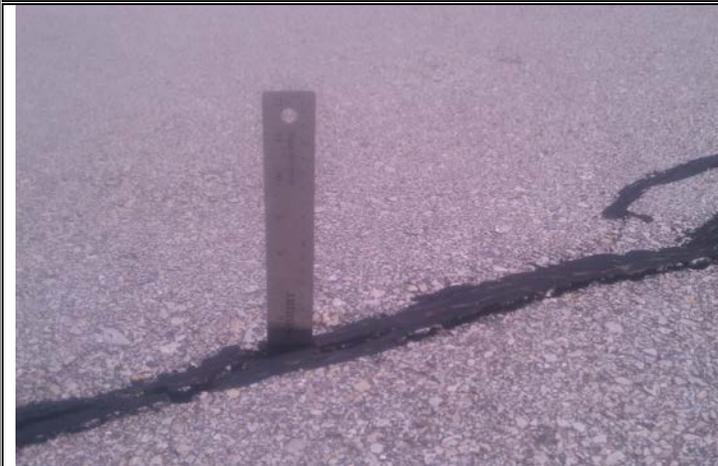
Date: June 12, 2013 Direction: SE
Photo Taken By: William Gamblin
Description: Ruler in crack MATCON southeast region. Ruler penetrated ~5 inches.

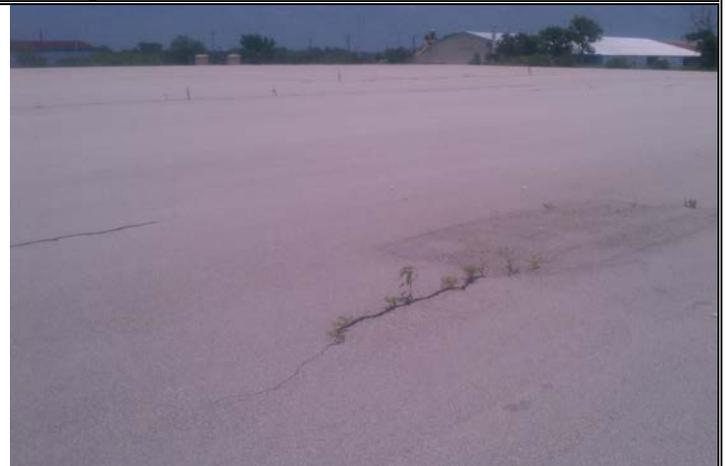
Date: June 12, 2013 Direction: NE
Photo Taken By: William Gamblin
Description: Vegetative growth in cracks in MATCON

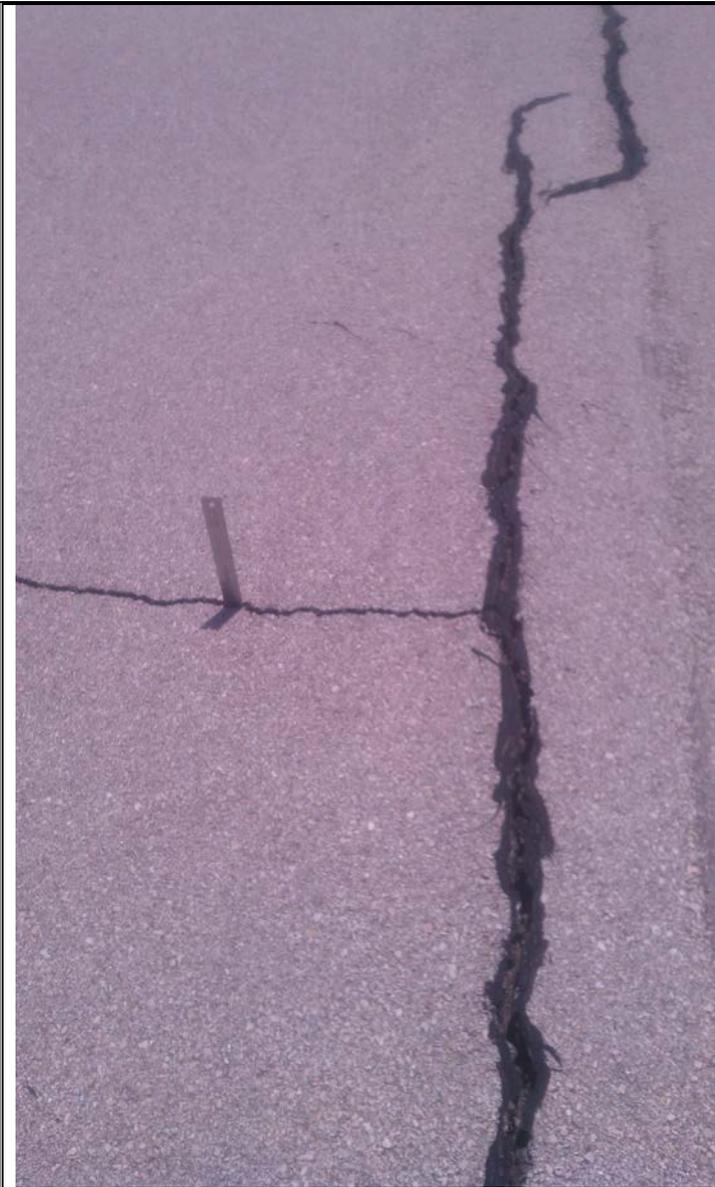
Date: June 12, 2013 Direction: S
Photo Taken By: William Gamblin
Description: Crack in MATCON southeast region.

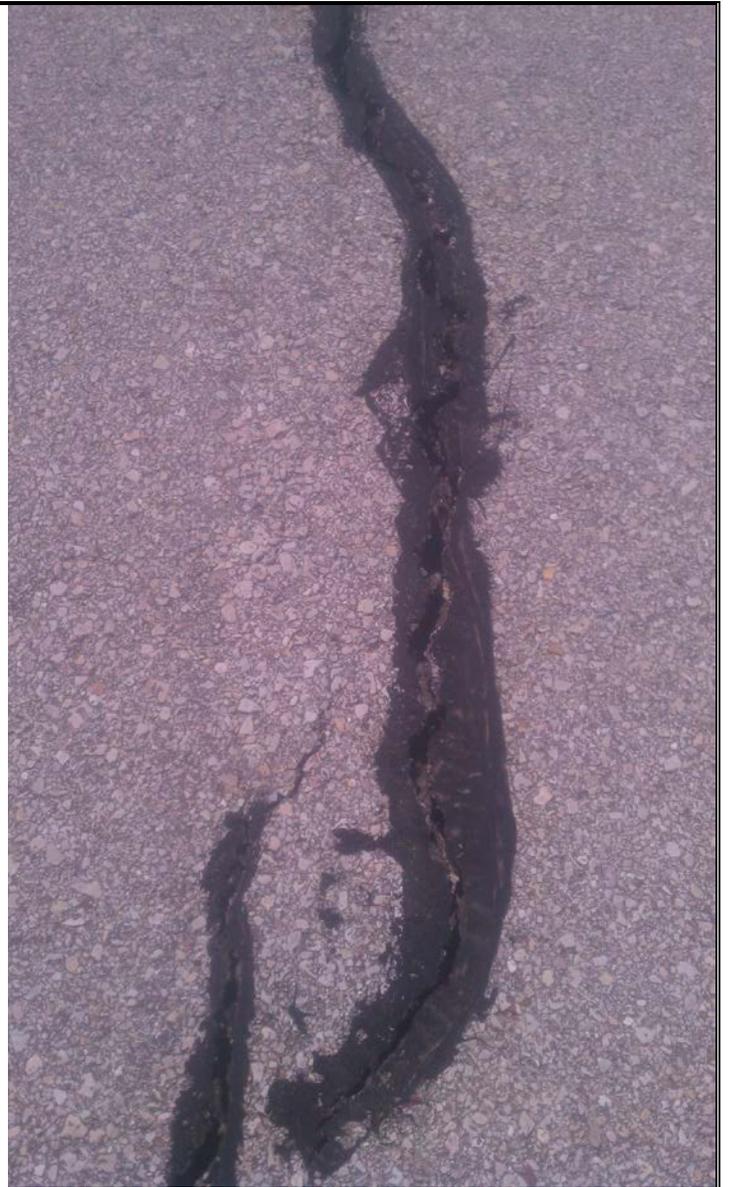
Date: June 12, 2013 Direction: W
Photo Taken By: William Gamblin
Description: Crack in MATCON southwest region.

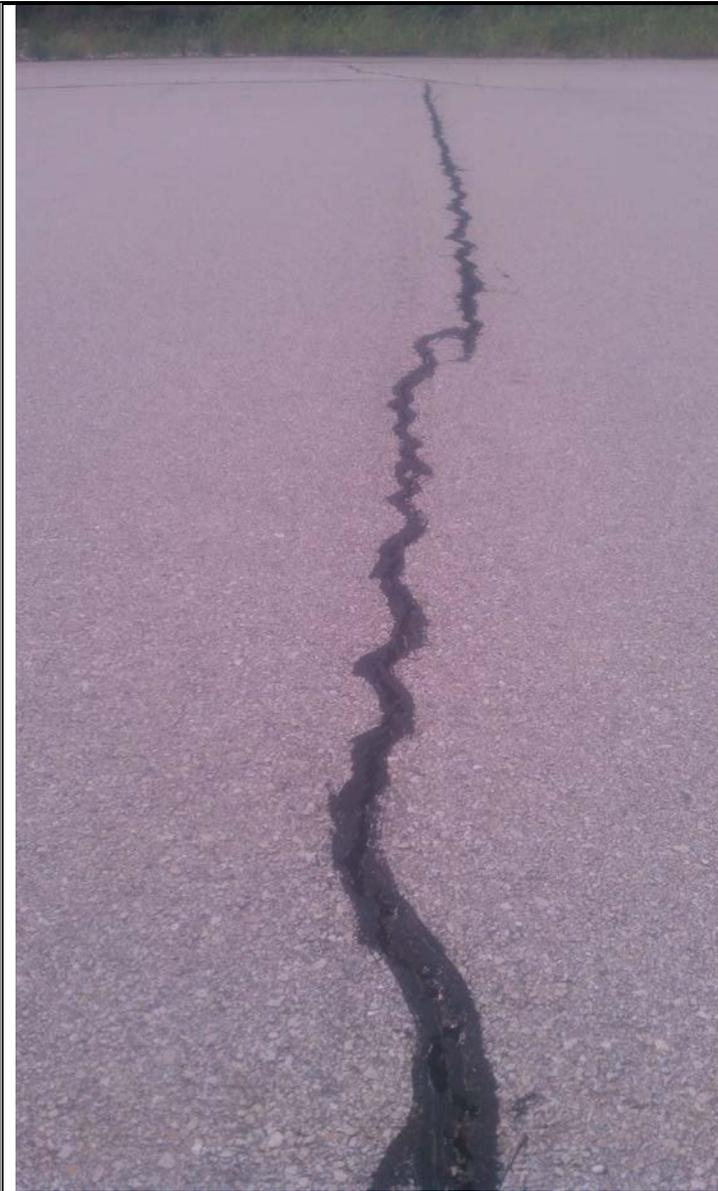
Date: June 12, 2013 Direction: W
Photo Taken By: William Gamblin
Description: Crack in MATCON southwest region.

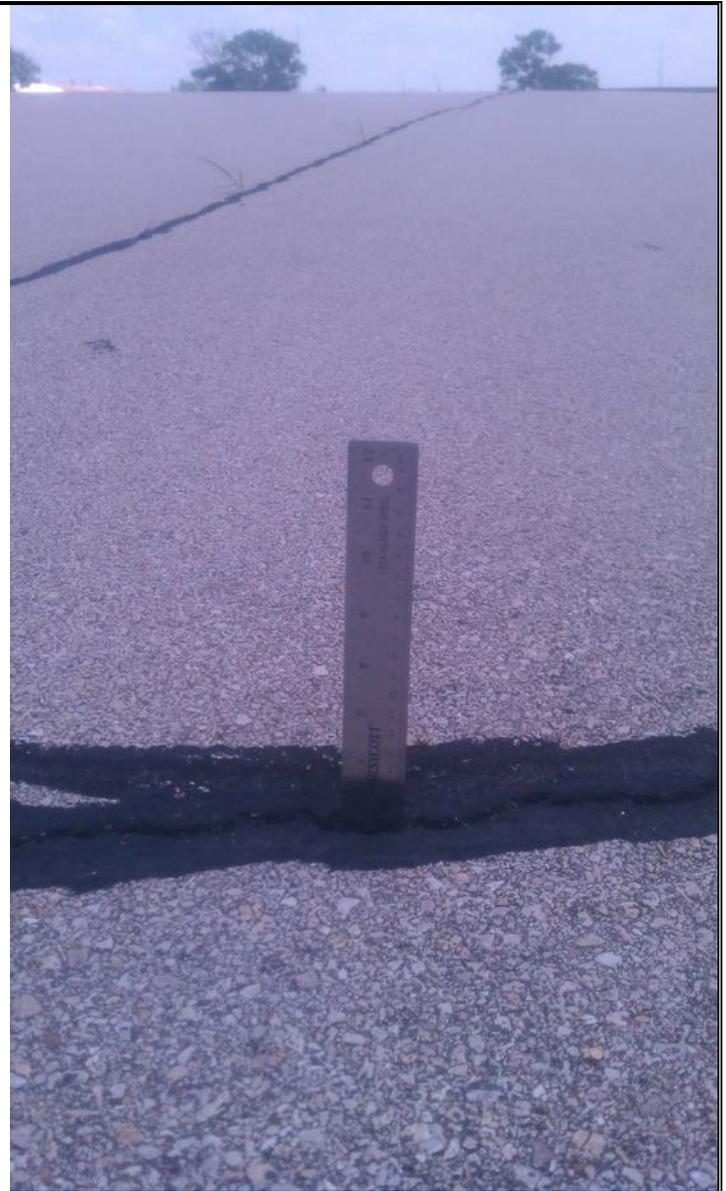
Date: June 12, 2013 Direction: E
Photo Taken By: William Gamblin
Description: Crack in MATCON southwest region.
Ruler penetrated ~5 inches.

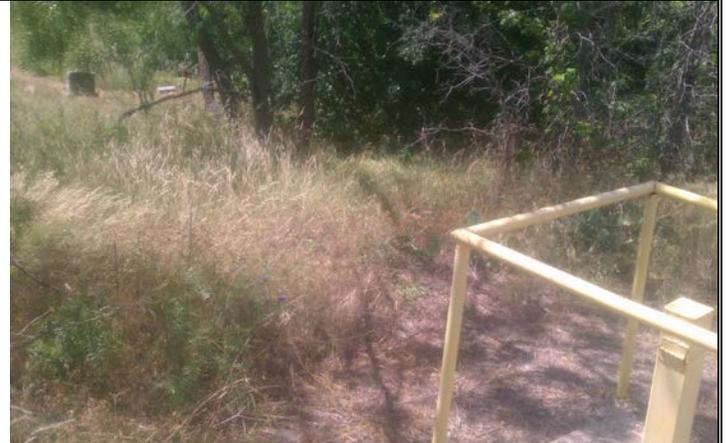
Date: June 12, 2013 Direction: NW
Photo Taken By: William Gamblin
Description: Fence down between cemetery and north property.

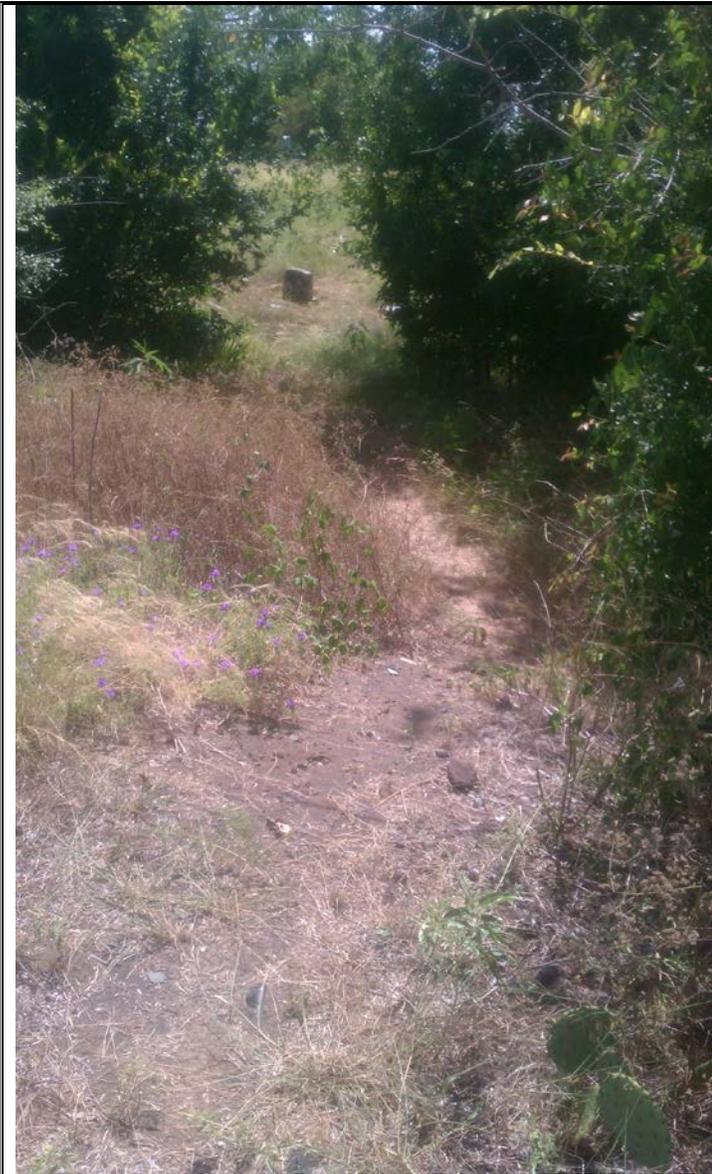
Date: June 12, 2013 Direction: SW
Photo Taken By: William Gamblin
Description: Fence down between cemetery and north property.

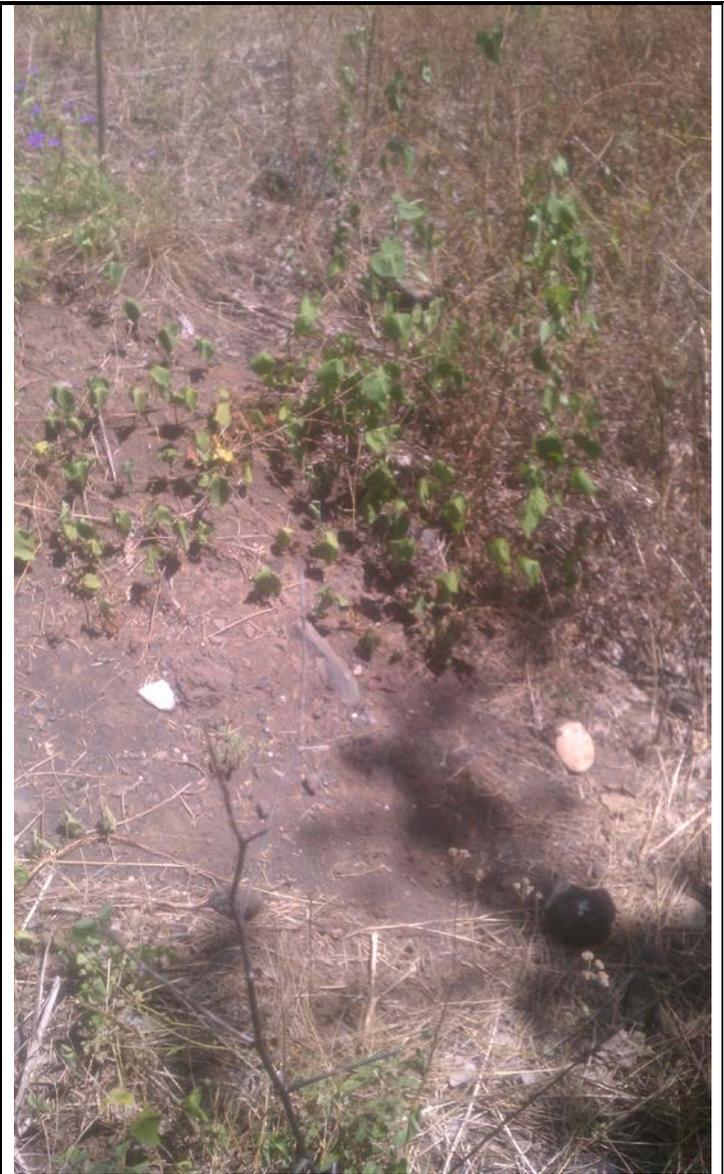
Date: June 12, 2013 Direction: SE
Photo Taken By: William Gamblin
Description: Slag looking debris on trail across downed fence between north property and cemetery.
