Field Summary Report Letter Report

**Rockwool Industries, Inc.
Federal Superfund Site
1741 Taylors Valley Road
Belton, Bell County, Texas**

July 11, 2013

Re: Rockwool Industries, Inc. / Belton, Site # SUP033, Field Summary Report

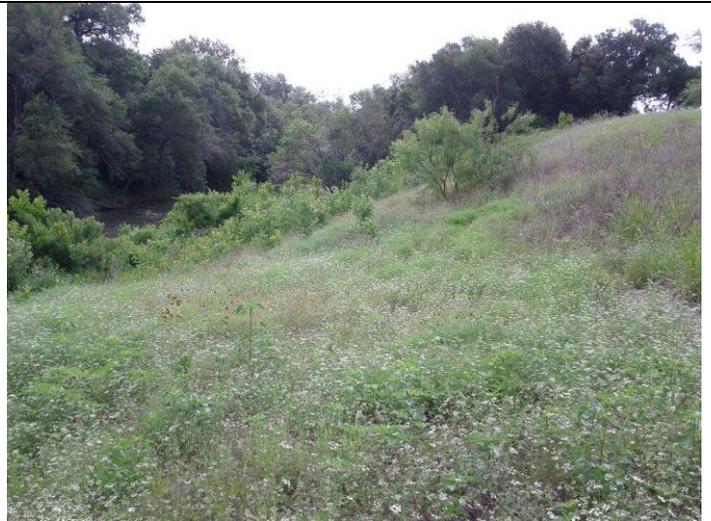
Date: May 28, 2013
Photo Taken By: Sara Eatman
Description: ACB reinforced riverbank before clearing from the top of the slope at approximately the midpoint (facing east).

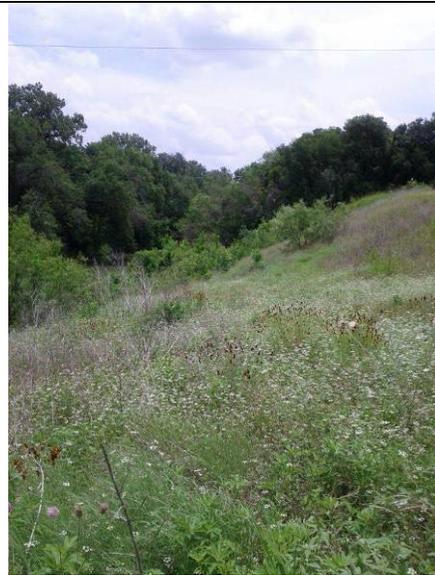
Date: May 28, 2013
Photo Taken By: Sara Eatman
Description: ACB reinforced embankment before clearing (looking E).

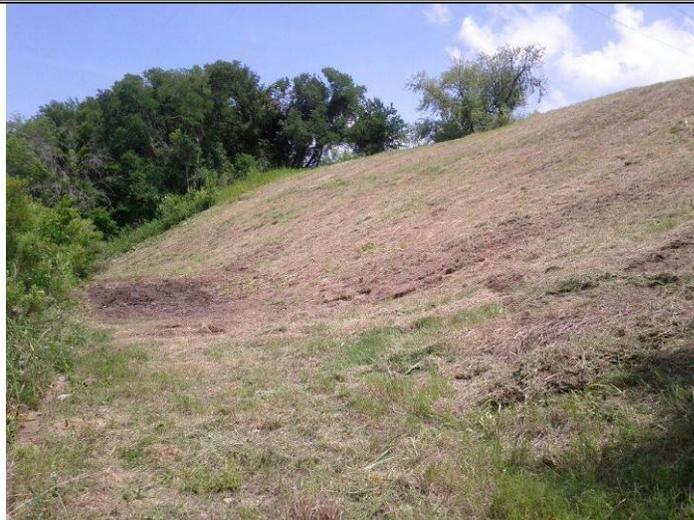
Date: May 28, 2013
Photo Taken By: Sara Eatman
Description: The eastern portion of the ACB reinforced embankment, cleared of brush (facing East)

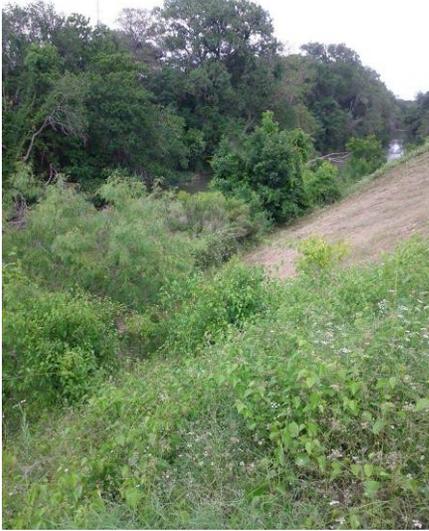
Date: May 28, 2013
Photo Taken By: Sara Eatman
Description: Remaining brush and bramble West of cleared area (facing East).

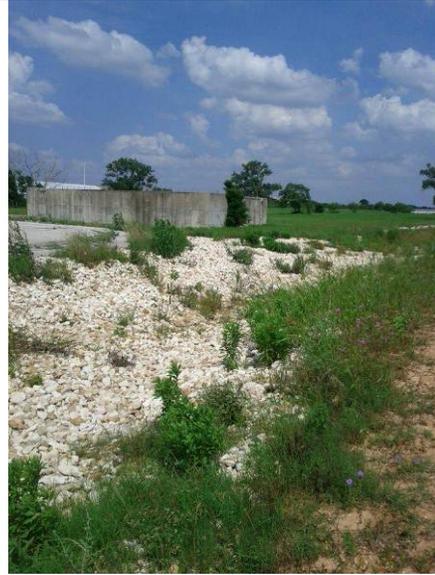
Date: May 28, 2013
Photo Taken By: Sara Eatman
Description: Central site, swale on the southern side of the MATCON cap showing some vegetation growth (facing East).

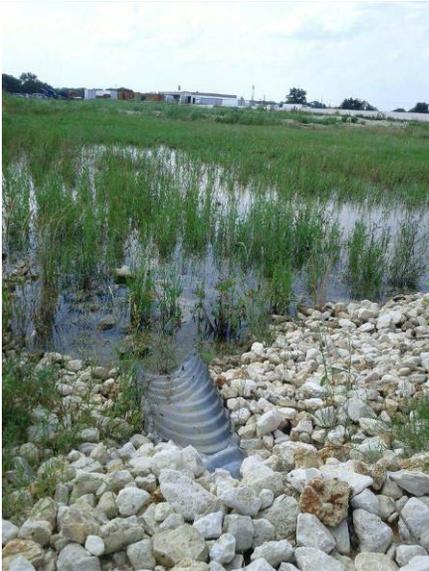
Date: May 28, 2013
Photo Taken By: Sara Eatman
Description: Central site, southeast corner of retention pond, showing some water from rainstorms the last two days, drainage culvert (facing Northwest).

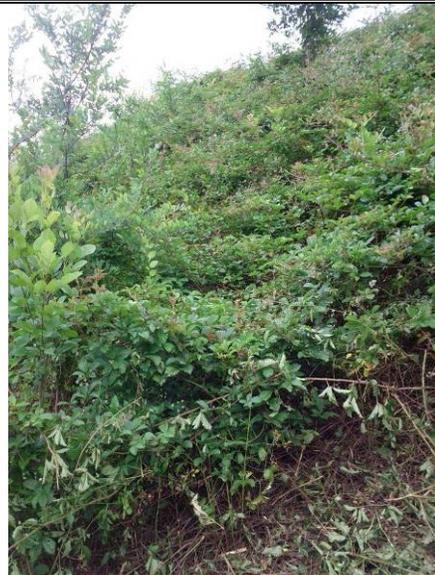
Date: May 30, 2013
Photo Taken By: Sara Eatman
Description: Dense bramble on lower western edge of the ACB reinforcement on the riverbank (looking West).

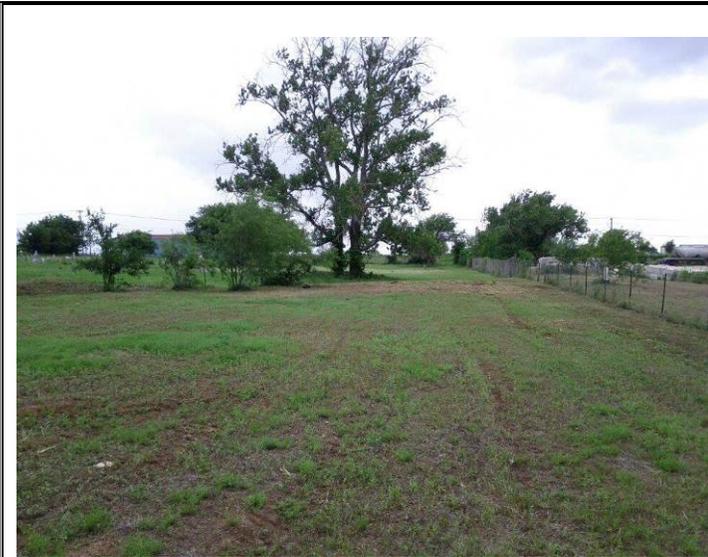
Date: May 30, 2013
Photo Taken By: Sara Eatman
Description: Eastern portion of the cemetery area after clearing (facing south).

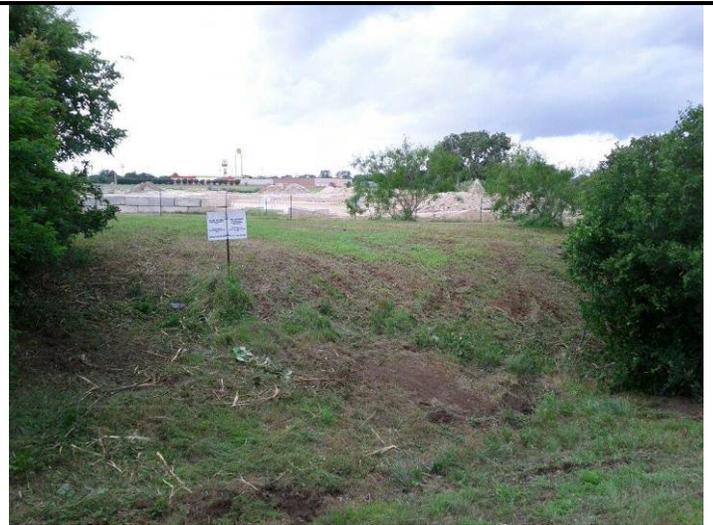
Date: May 30, 2013
Photo Taken By: Sara Eatman
Description: Eastern edge of the cemetery area after clearing (facing east).

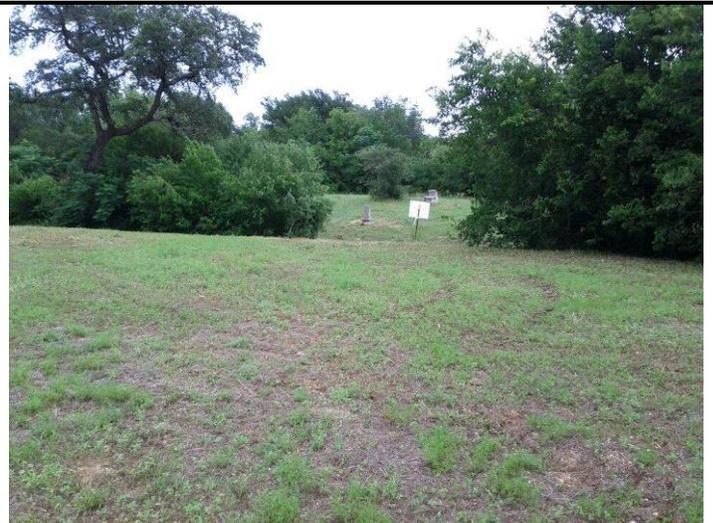
Date: May 30, 2013
Photo Taken By: Sara Eatman
Description: Eastern portion of the cemetery area after clearing (facing east).

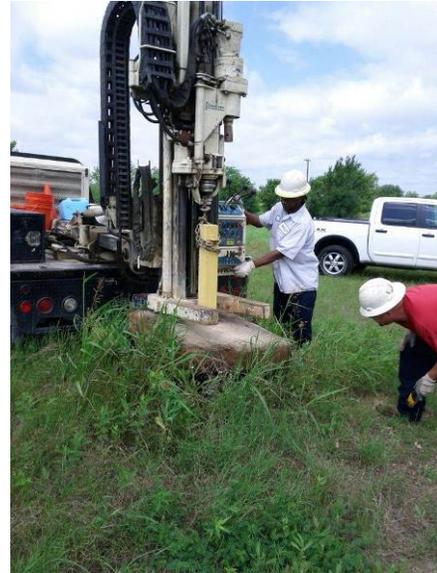
Date: May 31, 2013
Photo Taken By: Sara Eatman
Description: Magnacore Drilling crew removed well pad.

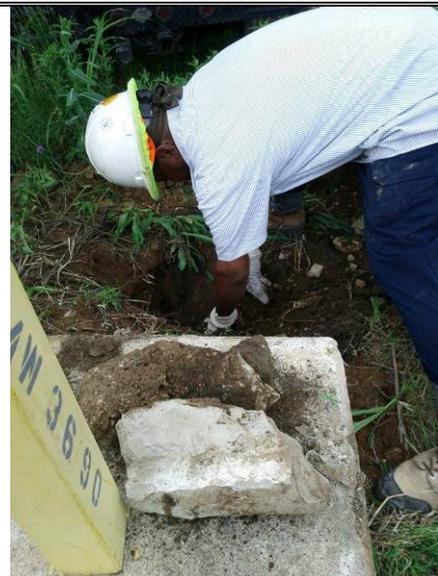
Date: May 31, 2013
Photo Taken By: Sara Eatman
Description: Attempting to remove casing, first try:
18 inch section broke off.

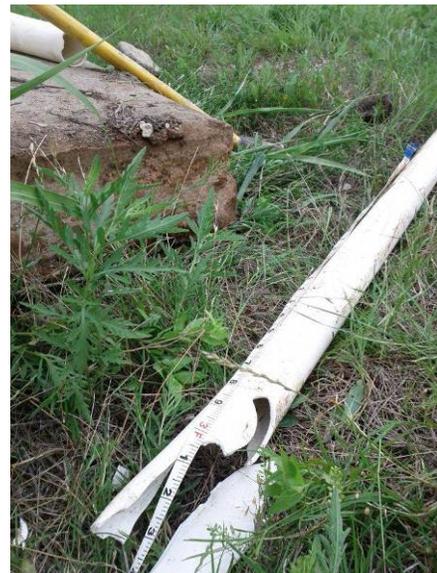
Date: May 31, 2013
Photo Taken By: Sara Eatman
Description: Second attempt to remove well casing, snapped after 3 ft. 5 inches.

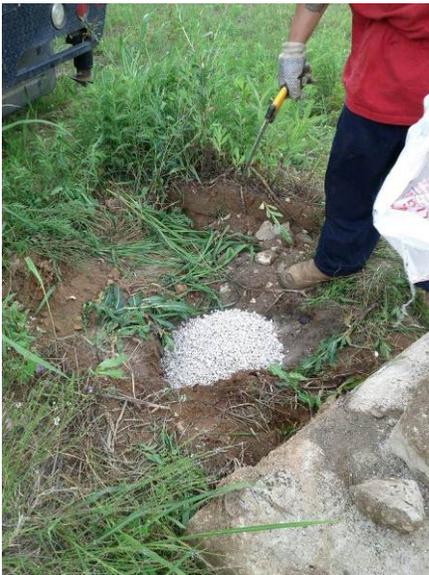
Date: May 31, 2013
Photo Taken By: Sara Eatman
Description: Third attempt to remove well casing; 5' 2" before it broke.

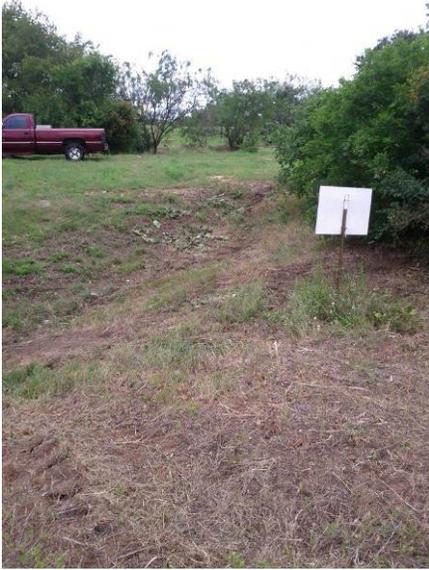
Date: June 1, 2013
Photo Taken By: Sara Eatman
Description: Gully on the eastern side of the cemetery area after clearing (looking southeast).

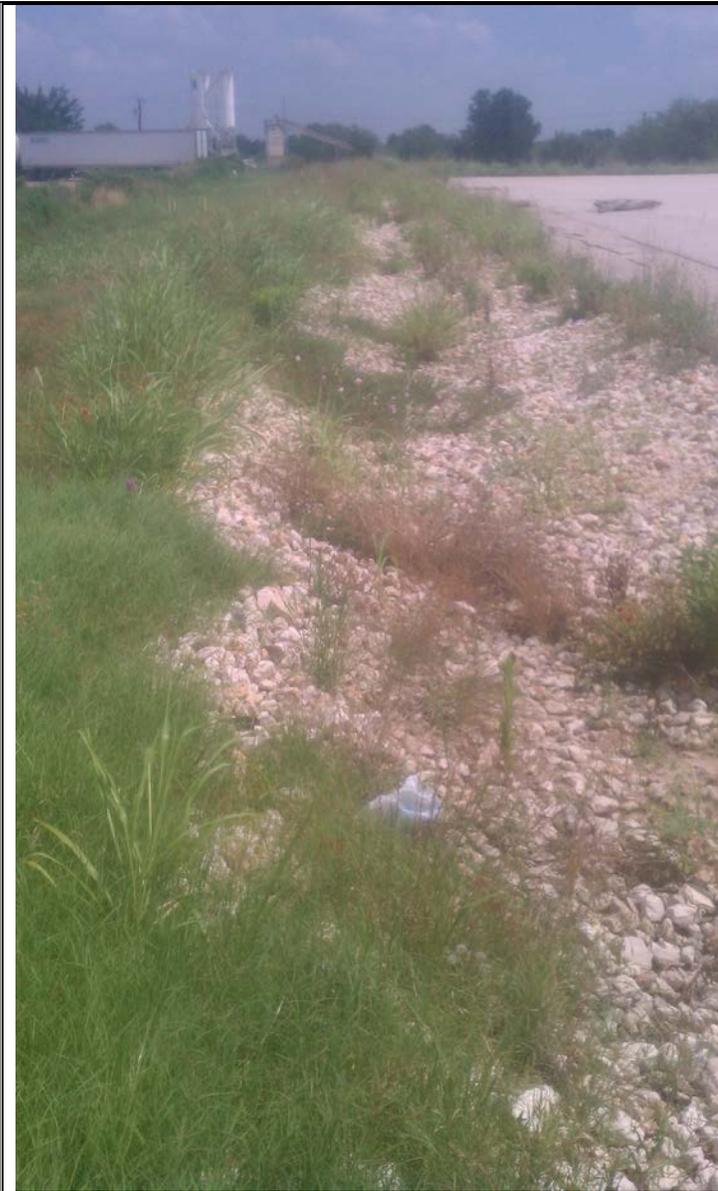
In general, the riprap installed in the perimeter drainage of the matcon and retention pond in August 2012 appears to be functioning properly to minimize erosion. The rip-rap was observed to still be in place with only one area discovered in the center of the southern edge of the MATCON cover where an approximately five foot section of rip-rap was washed out and the liner material was exposed (see page 21 of the photo documentation - Attachment 2). The integrity of the drainage ditch from the retention pond to the south fence and to the culvert on FM93 appears to be in good condition.

Date: June 12, 2013 Direction: N
Photo Taken By: William Gamblin
Description: West Drainage of MATCON

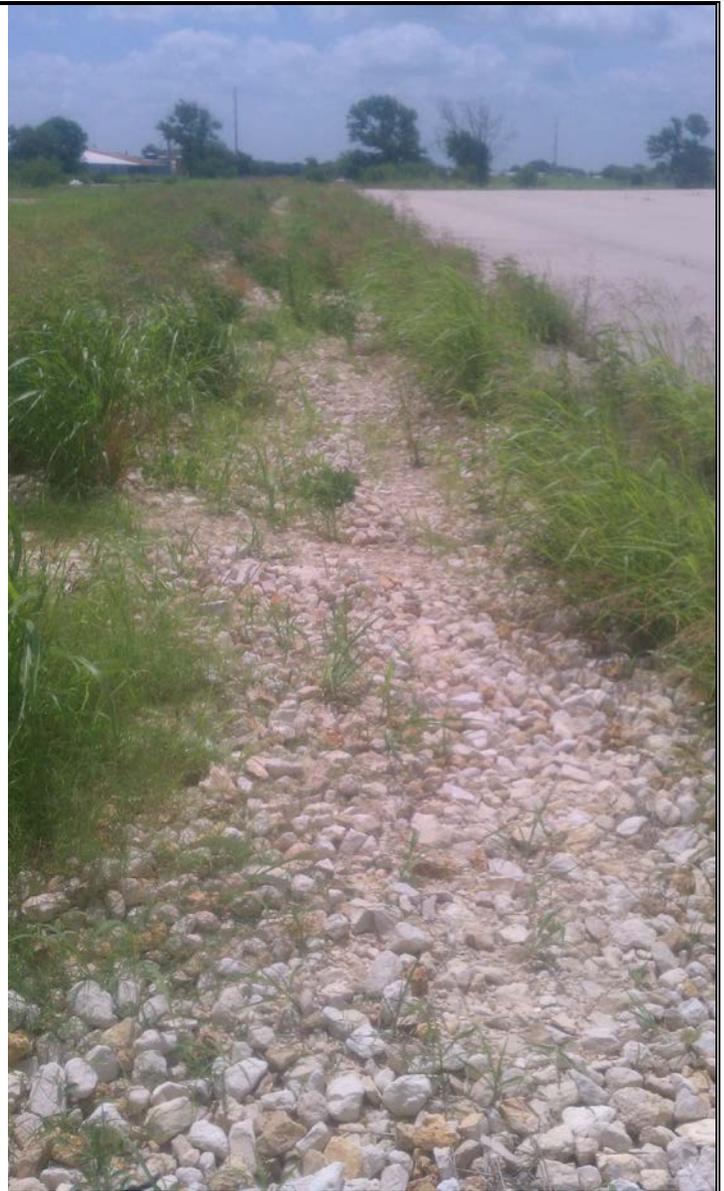
Date: June 12, 2013 Direction: E
Photo Taken By: William Gamblin
Description: North Drainage of MATCON

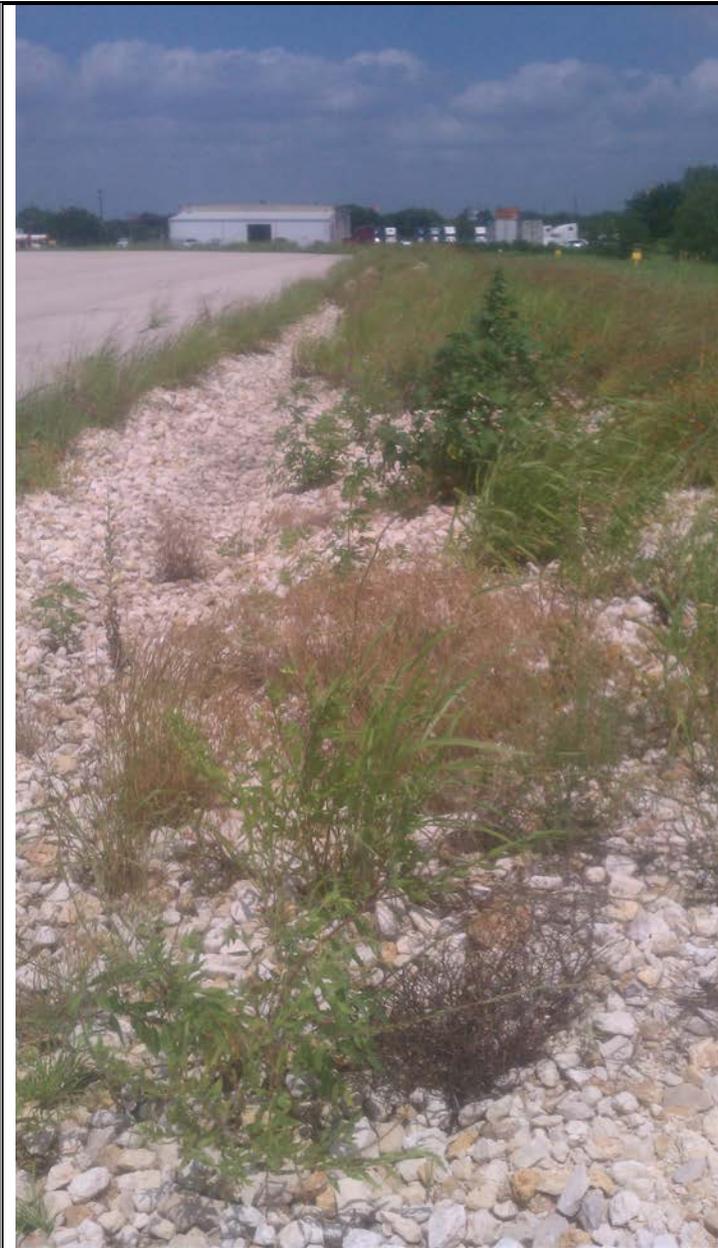
Date: June 12, 2013 Direction: W
Photo Taken By: William Gamblin
Description: North Drainage of MATCON

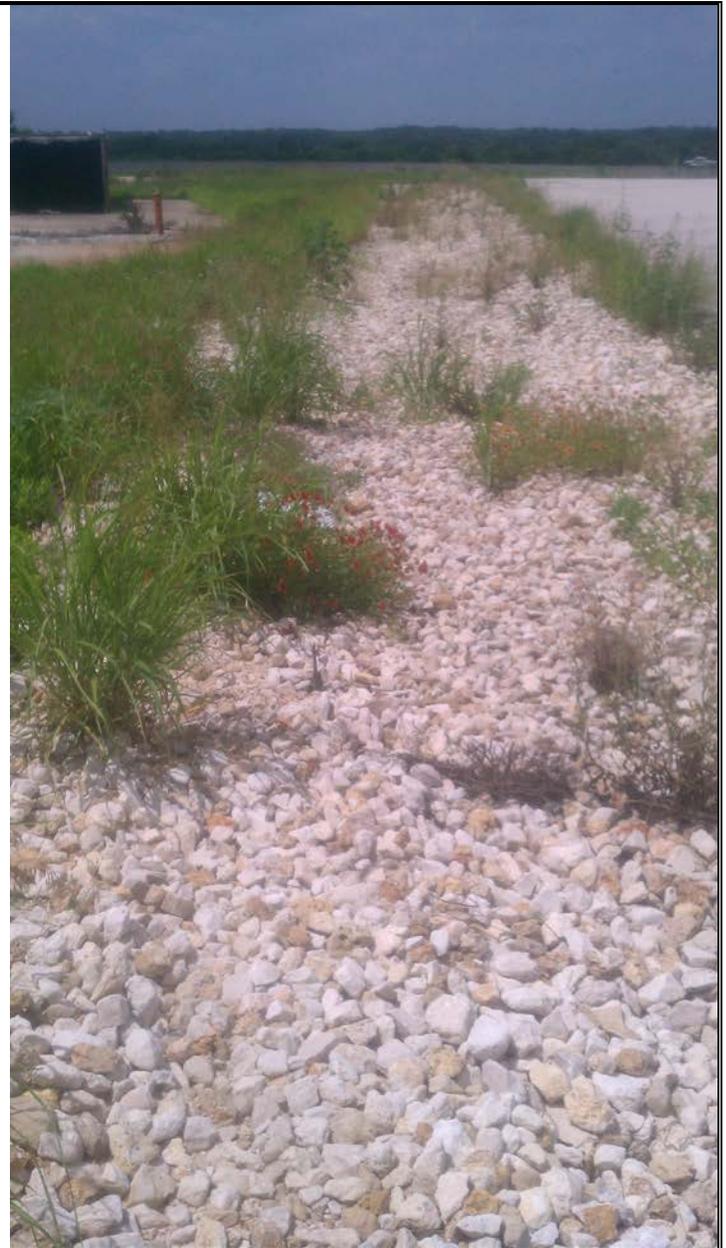
Date: June 12, 2013 Direction: S
Photo Taken By: William Gamblin
Description: East Drainage of MATCON

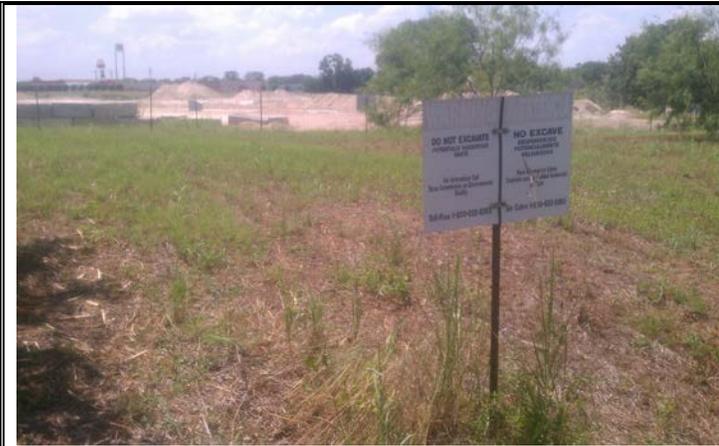
Date: June 12, 2013 Direction: W
Photo Taken By: William Gamblin
Description: Sign and area cleared west of cemetery.

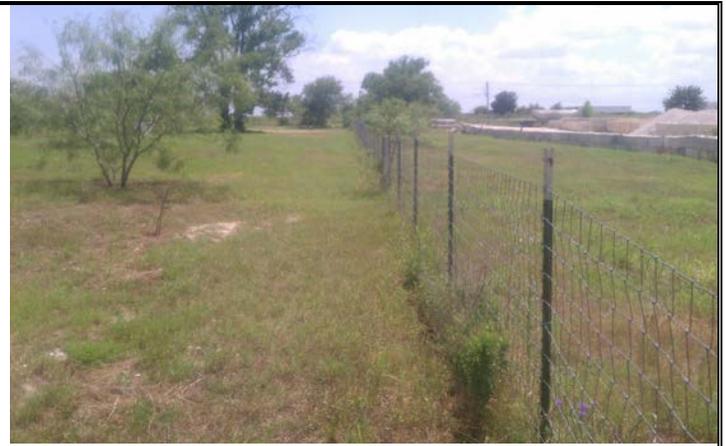
Date: June 12, 2013 Direction: S
Photo Taken By: William Gamblin
Description: Fence between cemetery and cement plant.

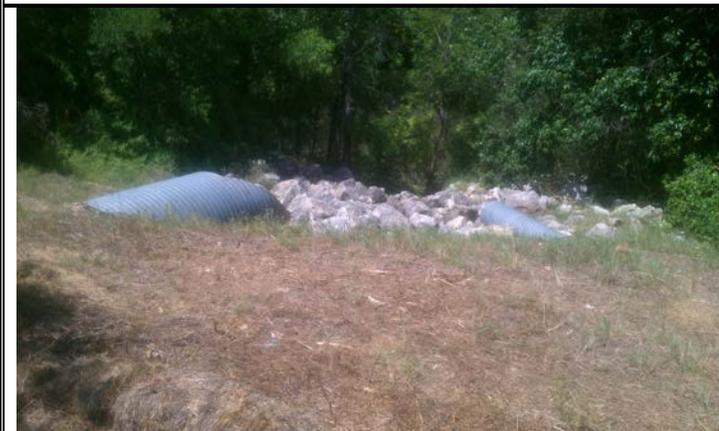
Date: June 12, 2013 Direction: NNW
Photo Taken By: William Gamblin
Description: Culverts exits and rock rubble.

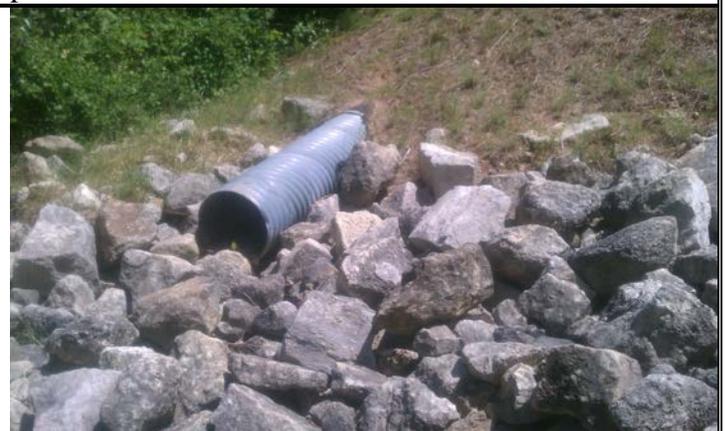
Date: June 12, 2013 Direction: ESE
Photo Taken By: William Gamblin
Description: Culverts exits and rock rubble.

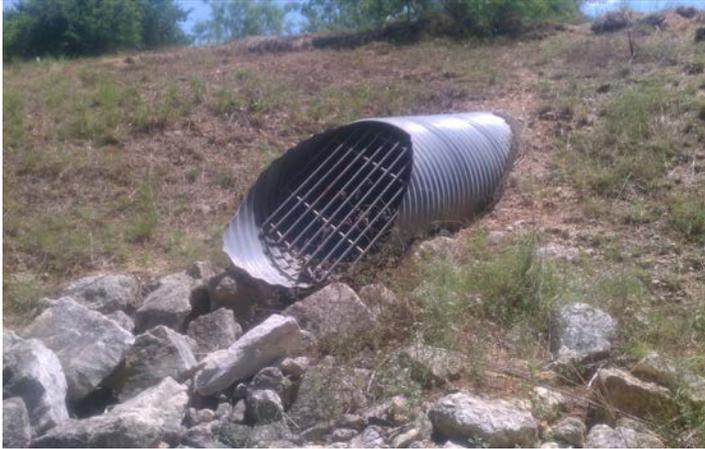
Date: June 12, 2013 Direction: SSE
Photo Taken By: William Gamblin
Description: Culverts exits and rock rubble.

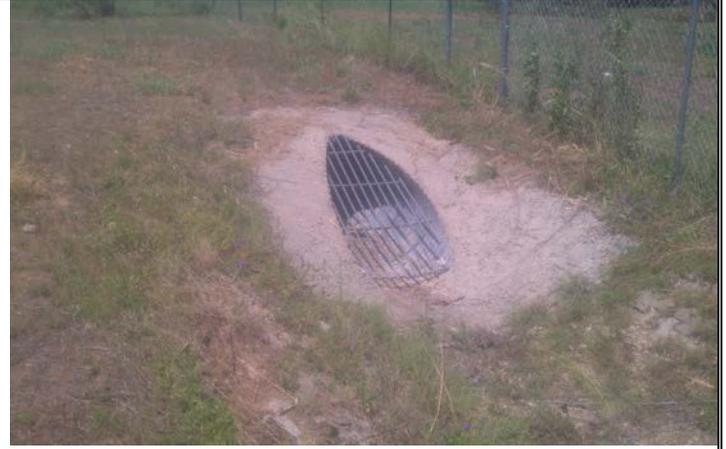
Date: June 12, 2013 Direction: SE
Photo Taken By: William Gamblin
Description: Culvert entrance near cement plant.

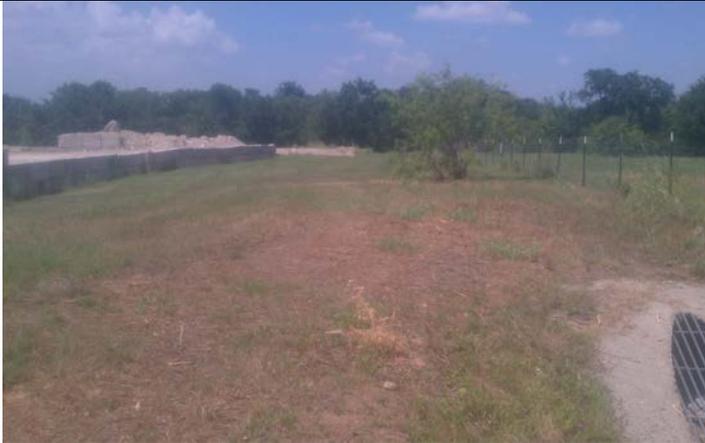
Date: June 12, 2013 Direction: N
Photo Taken By: William Gamblin
Description: Area cleared and fence between cemetery and cement plant.
